**NCHRP REPORT 350 TEST 4-11 OF THE  
ALASKA MULTI-STATE BRIDGE RAIL**

Research Project 404311-2  
**Contract No. T97232**

December 1998

**TEXAS TRANSPORTATION INSTITUTE  
THE TEXAS A & M UNIVERSITY SYSTEM  
COLLEGE STATION, TEXAS**

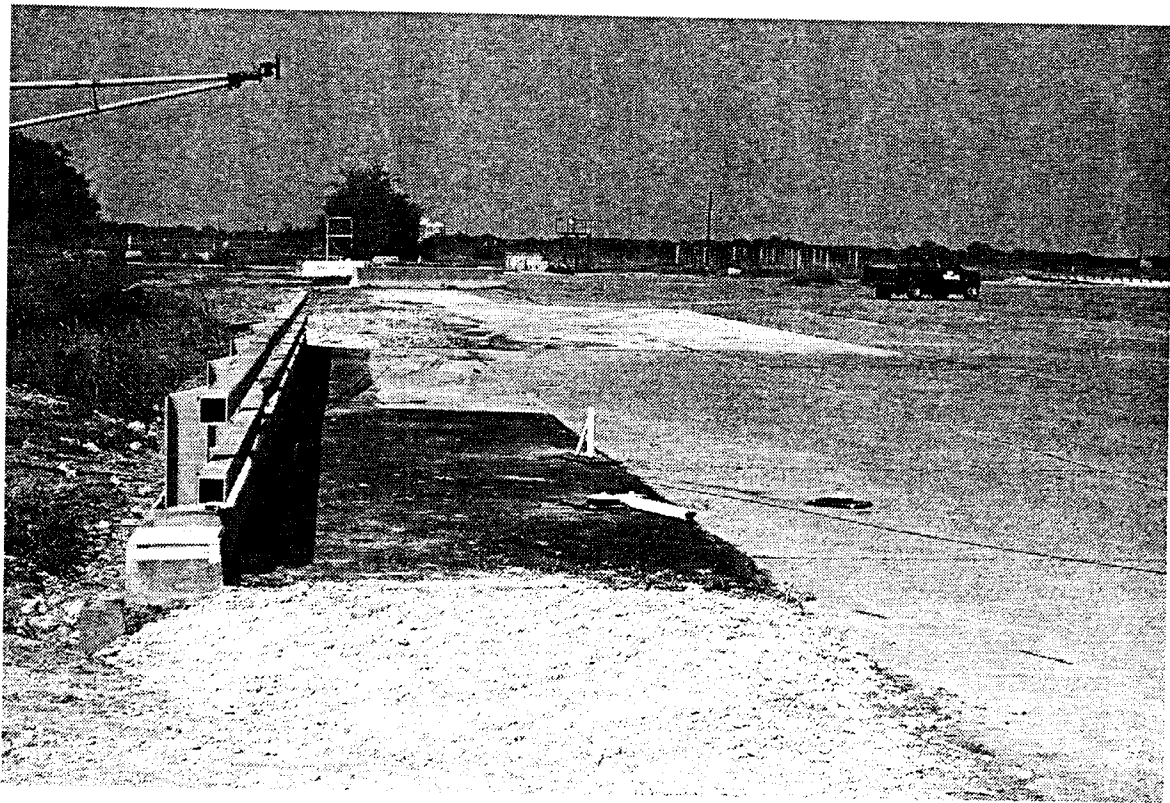
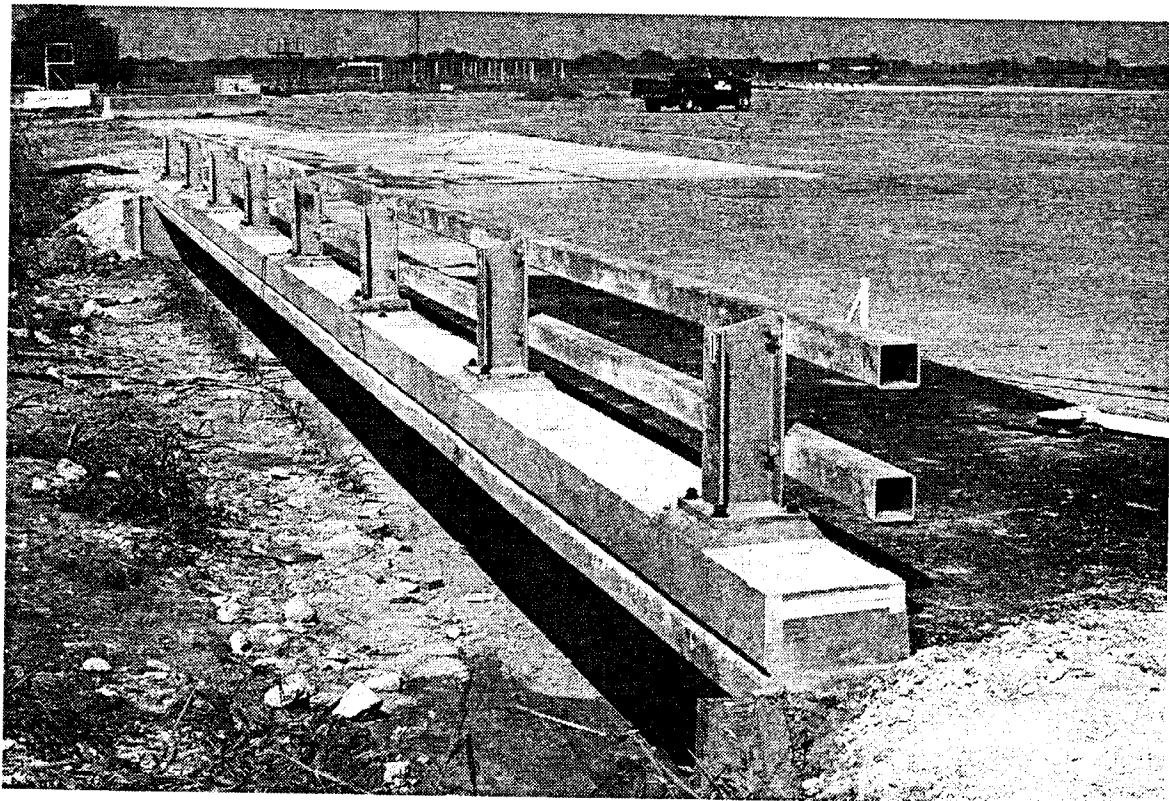
Figure 6. After impact trajectory for 404311-2.

The vehicle came to rest 24.4 m toward traffic lanes and intruded into adjacent traffic lanes.

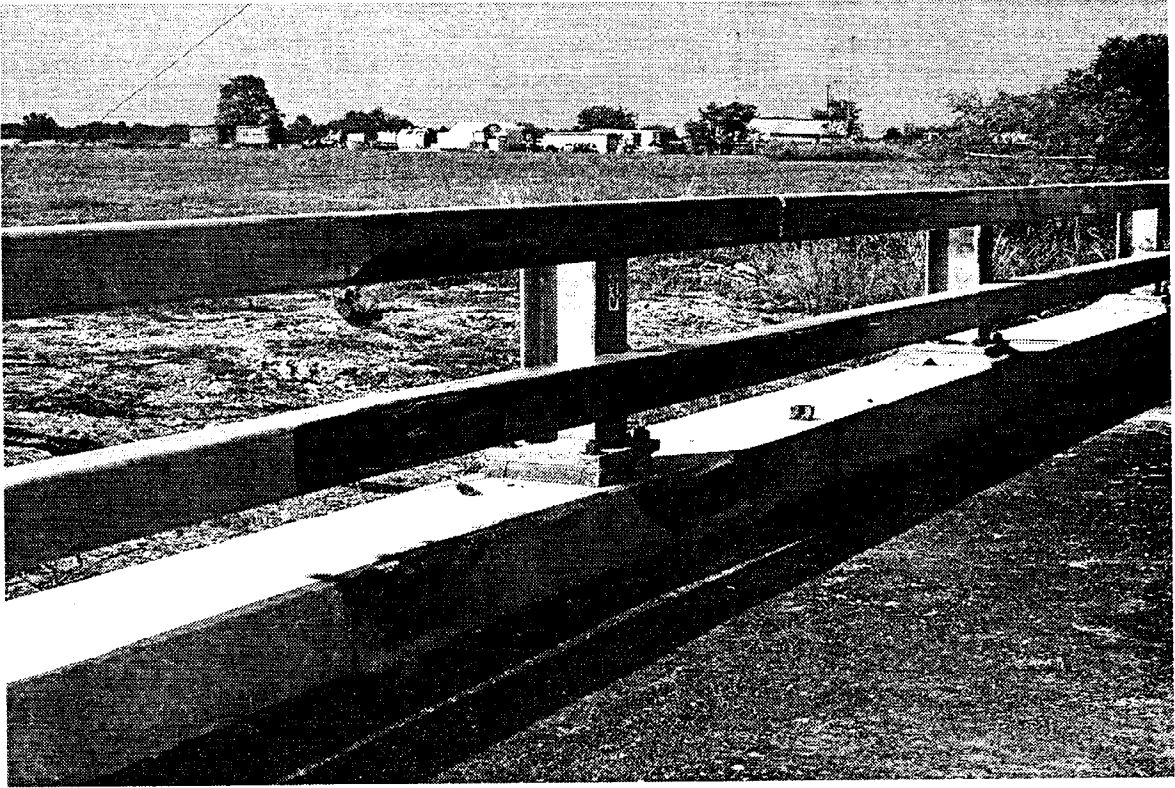
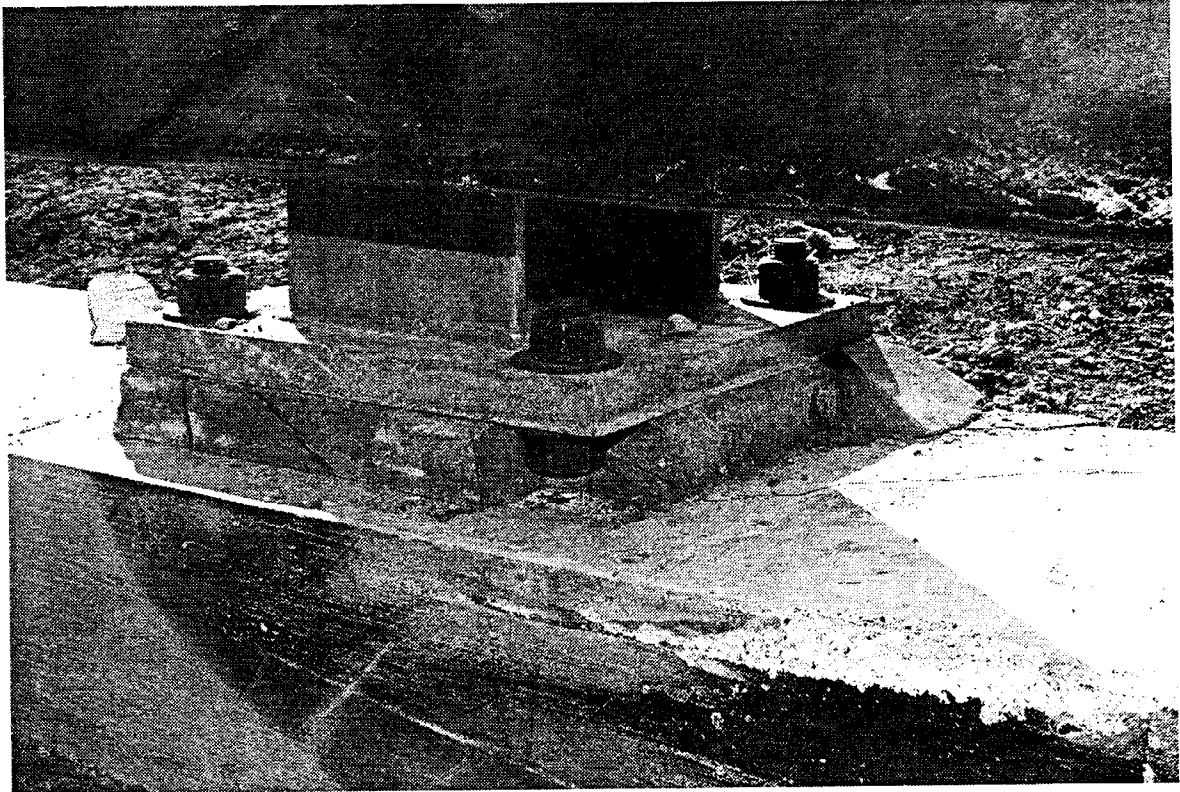
Figure 7. Damage to rail at post 3 after test 404311-2.

Damage to the Alaska Multi-State Bridge Railing mounted on the curb is shown in figures 6 thru 8. At impact the edge of the curb was scraped, and tire marks were along the face of the curb. Deflection at post 3 during the test was 0.40 m. Cracks in the bridge deck radiated out from the front and rear bolts and at post 3 the grout was missing at the front and sides of the base plate. The front face of post 3 was marred with blue paint from the vehicle and the curb was chipped. Total length of contact of the vehicle with the bridge railing was 4.8 m.

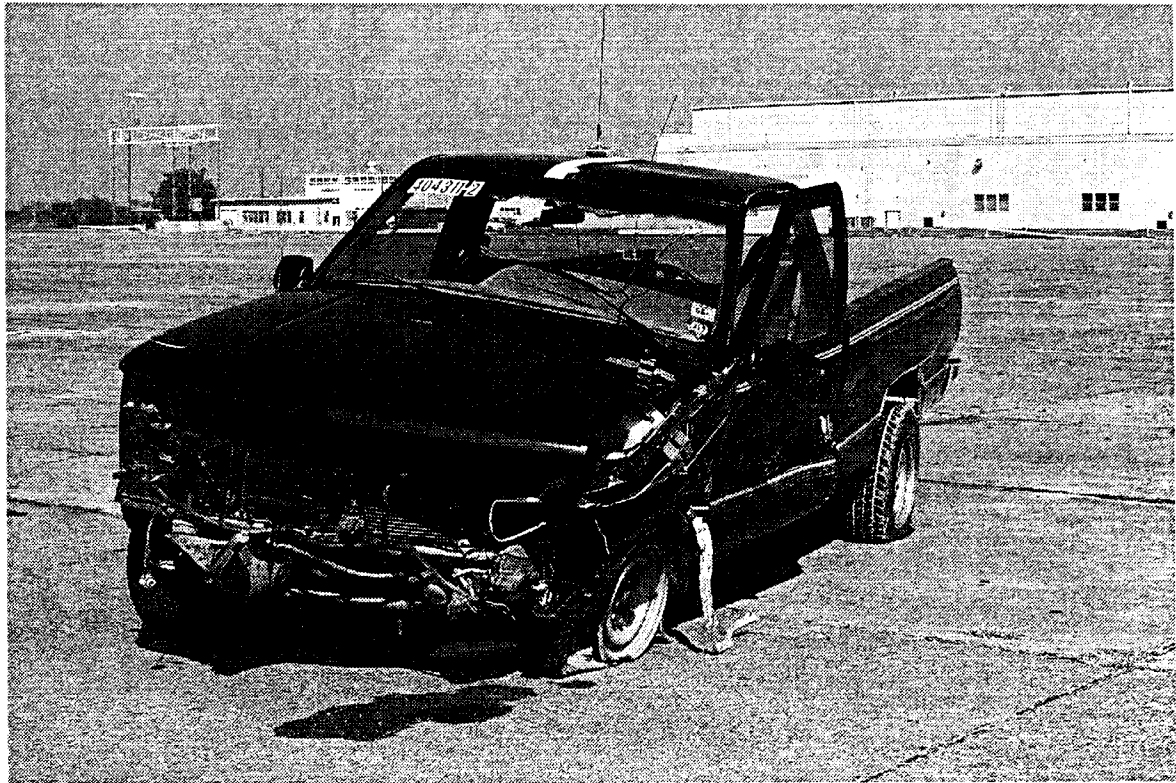
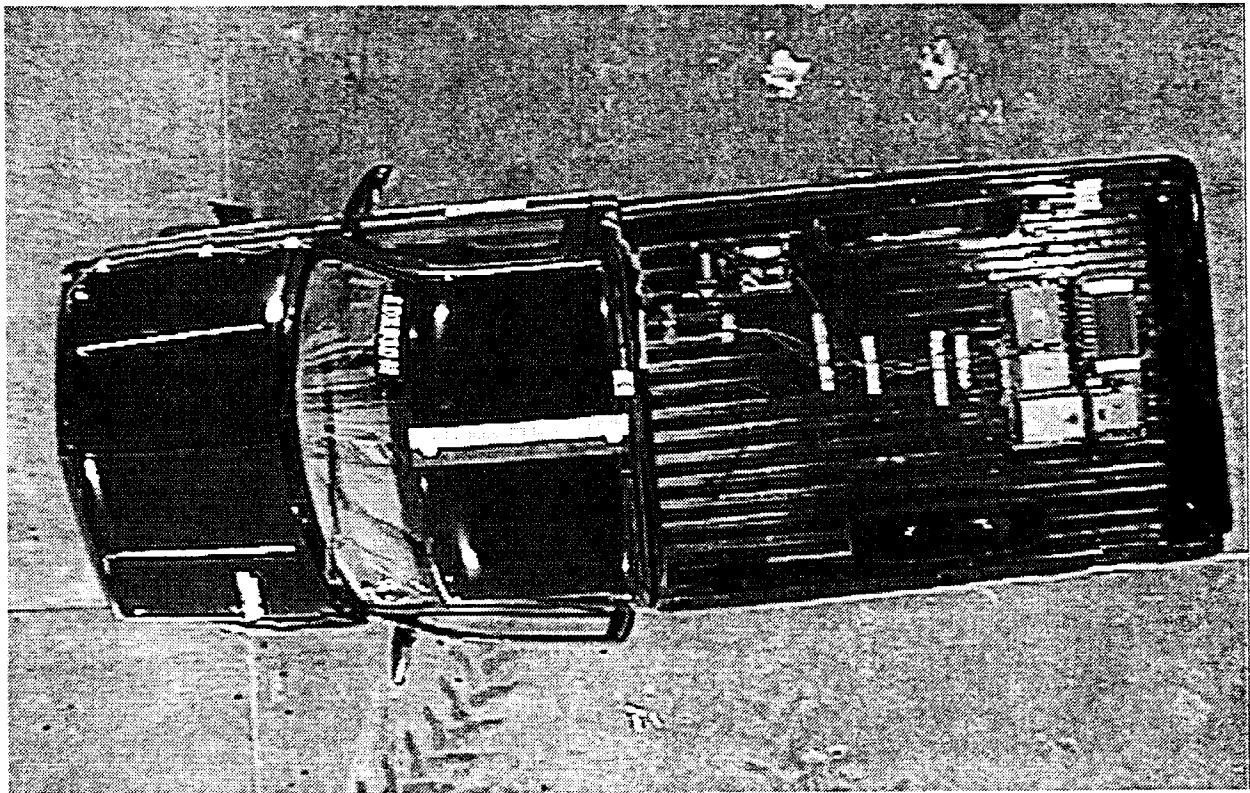
Figure 9. Vehicle after test 404311-2.

The vehicle sustained structural damage to the sway bar, left outer tie rod, left frame rail and left A-arm. The front left portion of the bumper, hood, grill, fan and radiator were deformed as shown in figure 9. Both left side tires and rims were damaged. The windshield was shattered and the left door had a gap that measured 170 mm. The left front and rear quarter panels were dented. The cab of the vehicle was pushed against the bed of the vehicle and the driver's side dash was bent up and pushed forward. The maximum exterior crush to the radiator support was 540 mm and at 900 mm above the ground to the left side of the bumper measured 405 mm. Maximum deformation of the occupant compartment was 115 mm (7 percent reduction in space) in the lateral direction near the occupant's feet, 60 mm (4 percent reduction in space) in the firewall area and 37 mm (3 percent reduction in space) in the floor pan area. The interior of the vehicle is shown in figure 10. Exterior vehicle crush and occupant compartment measurements are shown in appendix C, tables 2 and 3.

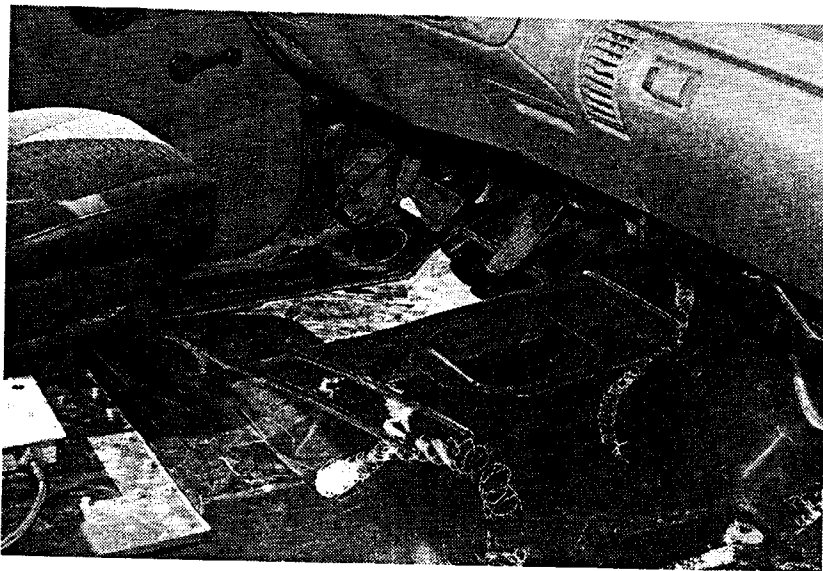
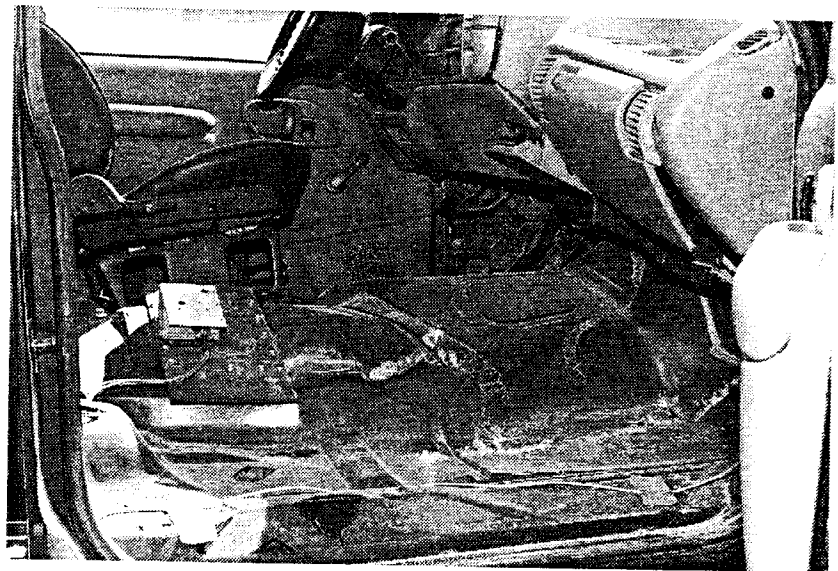
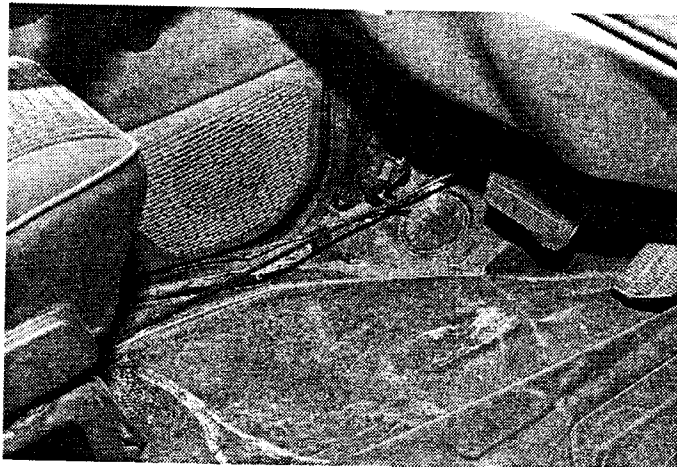
Figure 10. Interior of vehicle for test 404311-2.

No detached elements, fragments or other debris were present to penetrate nor to show potential for penetrating the occupant compartment, nor to present undue hazard to others in the area. Maximum deformation of the occupant compartment was 115 mm (7% reduction in space) in the lateral deformation near the occupant's feet.
