**NCHRP REPORT 350 TEST 4-22 OF THE
ALASKA MULTI-STATE BRIDGE RAIL THRIE-BEAM TRANSITION**

Contract No. T97232
Research Project 404311-6

July 1999

**TEXAS TRANSPORTATION INSTITUTE
THE TEXAS A & M UNIVERSITY SYSTEM
COLLEGE STATION, TEXAS**

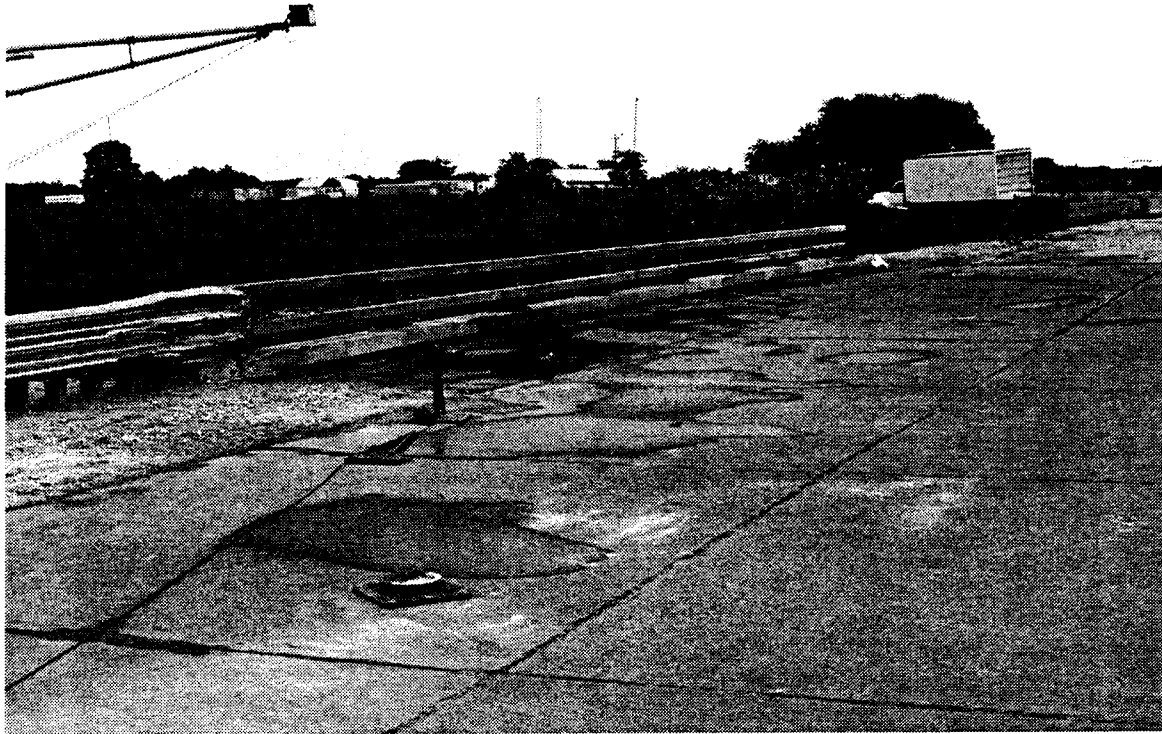
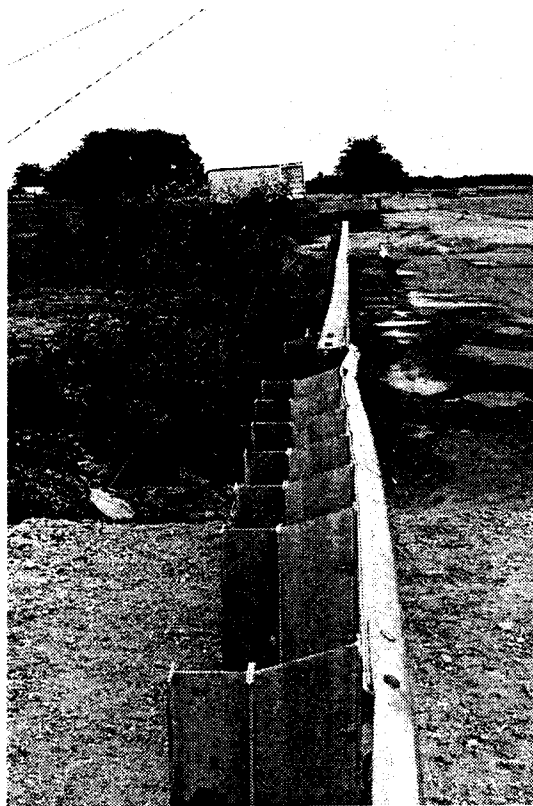
Figure 7. Vehicle trajectory path after test 404311-6.

The 8000S vehicle did not intrude into adjacent traffic lanes.

Exit angle at loss of contact was not attainable from the overhead camera. However, estimating from tire marks at the test site, the exit angle was approximately 1 degree which was less than 60 percent of the impact angle.

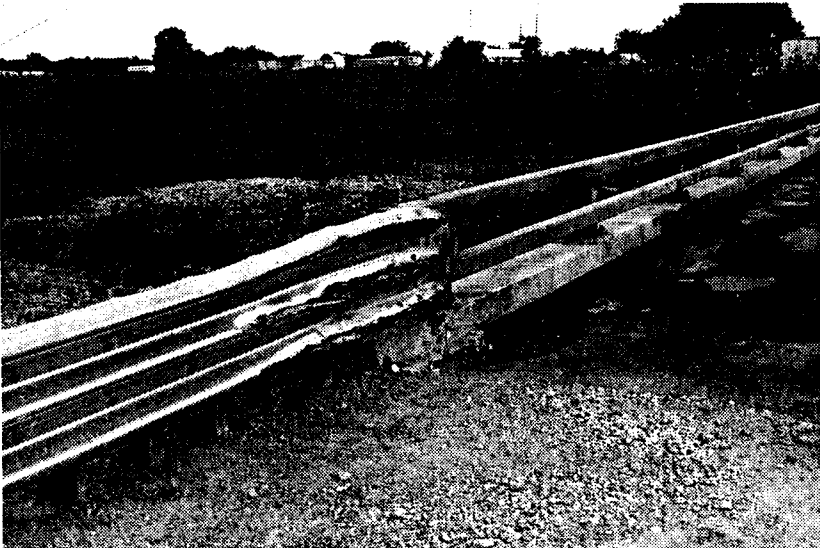
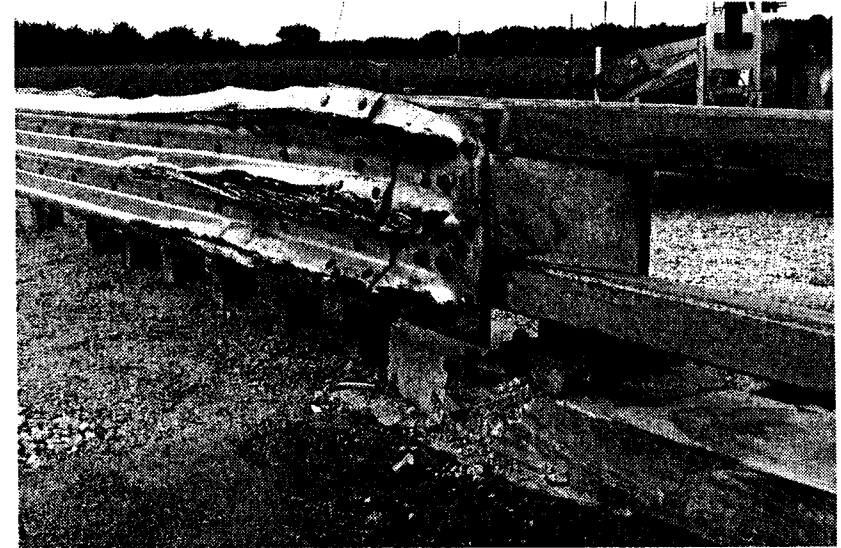
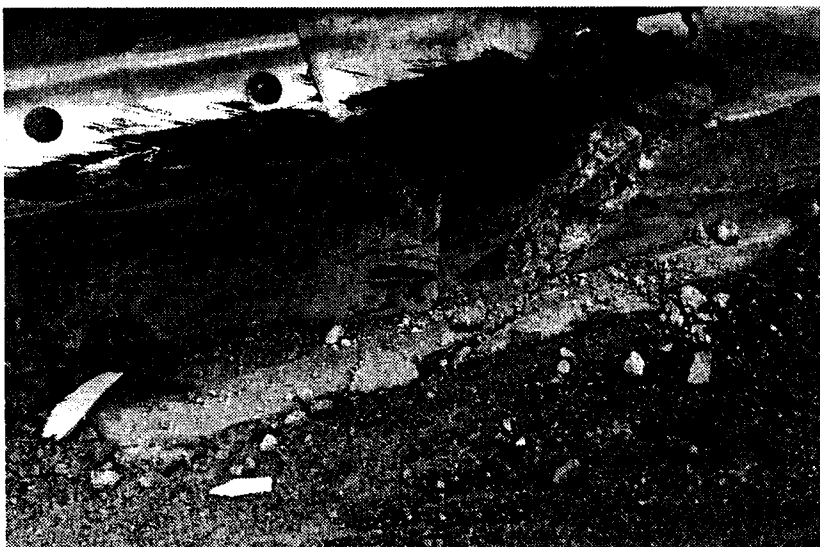
Figure 8. Installation after test 404311-6.

Minimal damage was sustained by the transition as shown in figures 7 and 8. However, structural damage was imparted to the bridge deck around post 20 (the first bridge rail post). Post 1 through post 14 were disturbed, post 15 moved back 5 mm and post 16 moved back 9 mm. Post 17 was pushed back 22 mm, post 18 was pushed back 44 mm and post 19 was pushed back 42 mm. The end of the curb at the edge of the bridge deck was cracked and pushed back 2 mm. The vehicle was in contact with the transition and bridge rail for a total of 5.0 m. Maximum dynamic deflection of the rail during the test was 77 mm and maximum permanent deformation of the rail was 49 mm.

The Alaska Multi-State Bridge Rail Transition contained and redirected the 8000S vehicle. The vehicle did not penetrate, underride, or override the installation, however, structural damage did occur to the bridge deck. Maximum dynamic deflection of the rail was 77 mm.

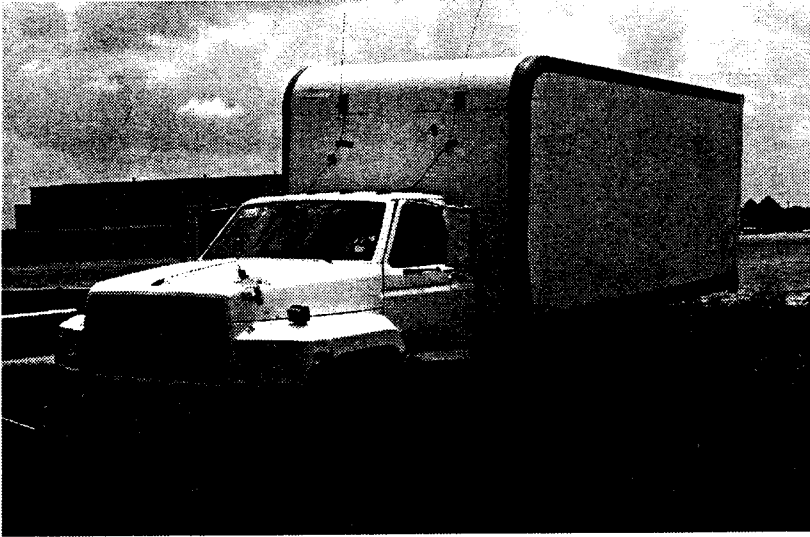
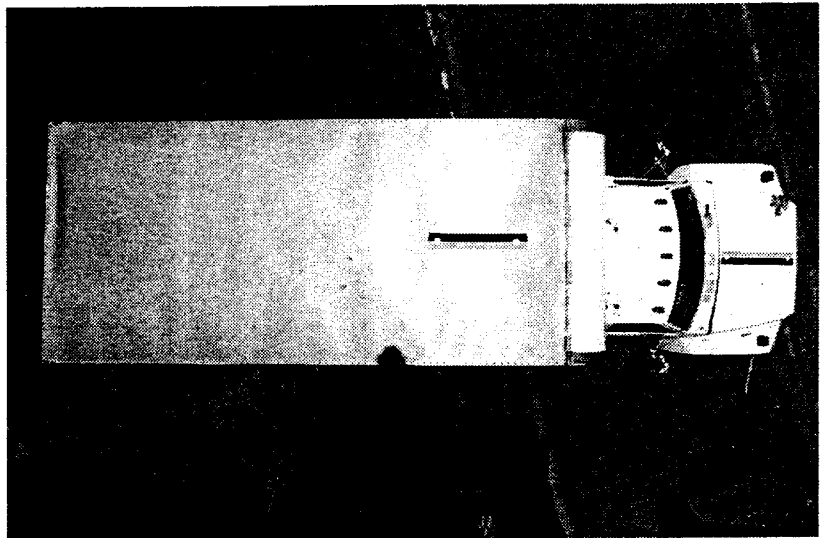
Figure 9. Vehicle after test 404311-6.

Damage to the vehicle is shown in figure 9. The left side of the front axle was separated from the vehicle and the left side spring, U-bolts, shock, rod ends and steering arm were damaged. The front bumper, grill, left front quarter panel, and left side door were deformed. The left front tire and wheel rim and the left rear outside tire and wheel rim were damaged. The lower edge of the box van was damaged and the floor pan on the left side was deformed slightly. Photographs of the interior of the vehicle are shown in figure 10.

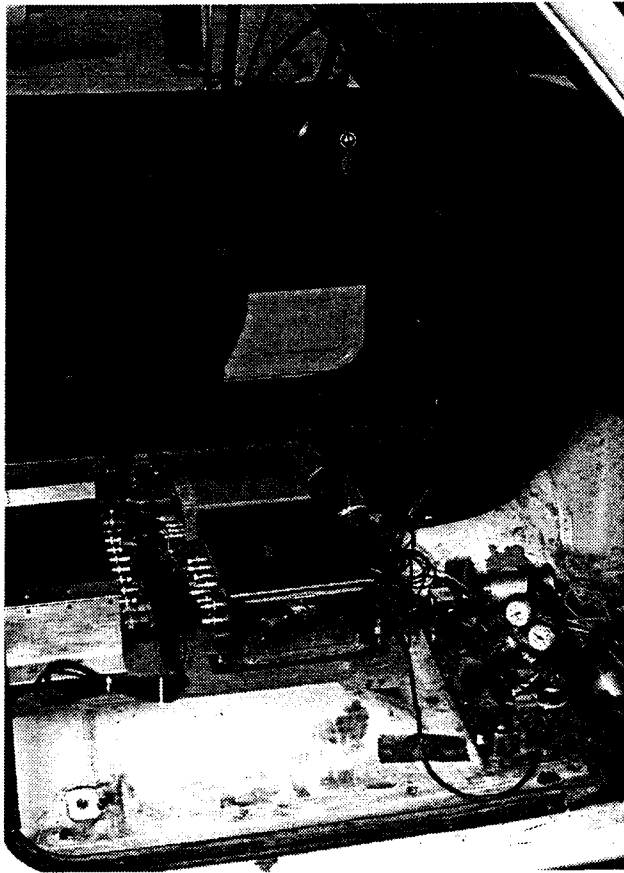
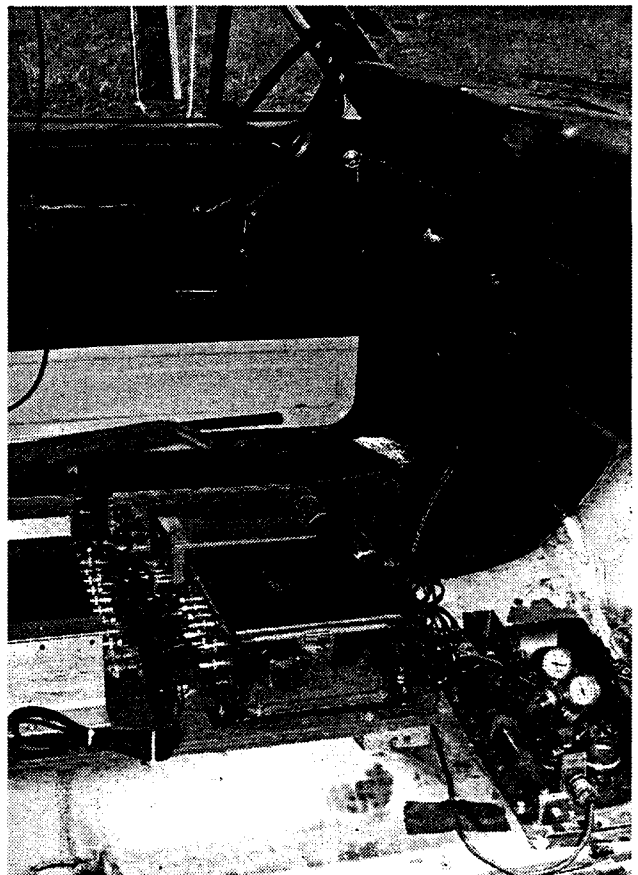
Figure 10. Interior of vehicle for test 404311-6.

No detached elements, fragments, or other debris were present to penetrate or to show potential for penetrating the occupant compartment, nor to present undue hazard to others in the area. Deformation of the occupant compartment was minimal, but not measurable.
