APPENDIX G

Bald Eagle Consultation and Conservation Measures

**AN ASSESSMENT OF PERCH USE
AND POSSIBLE IMPACTS OF
PROPOSED HAINES HIGHWAY
REALIGNMENTS ON BALD EAGLES
DURING FALL AND WINTER,
CHILKAT RIVER, ALASKA**

STATE OF ALASKA
 DEPARTMENT OF TRANSPORTATION
 AND PUBLIC FACILITIES
 DOT & PF Project No. 68606
 HAINES HIGHWAY
 MILEPOST 3.5 - 25.3
 Haines, Alaska

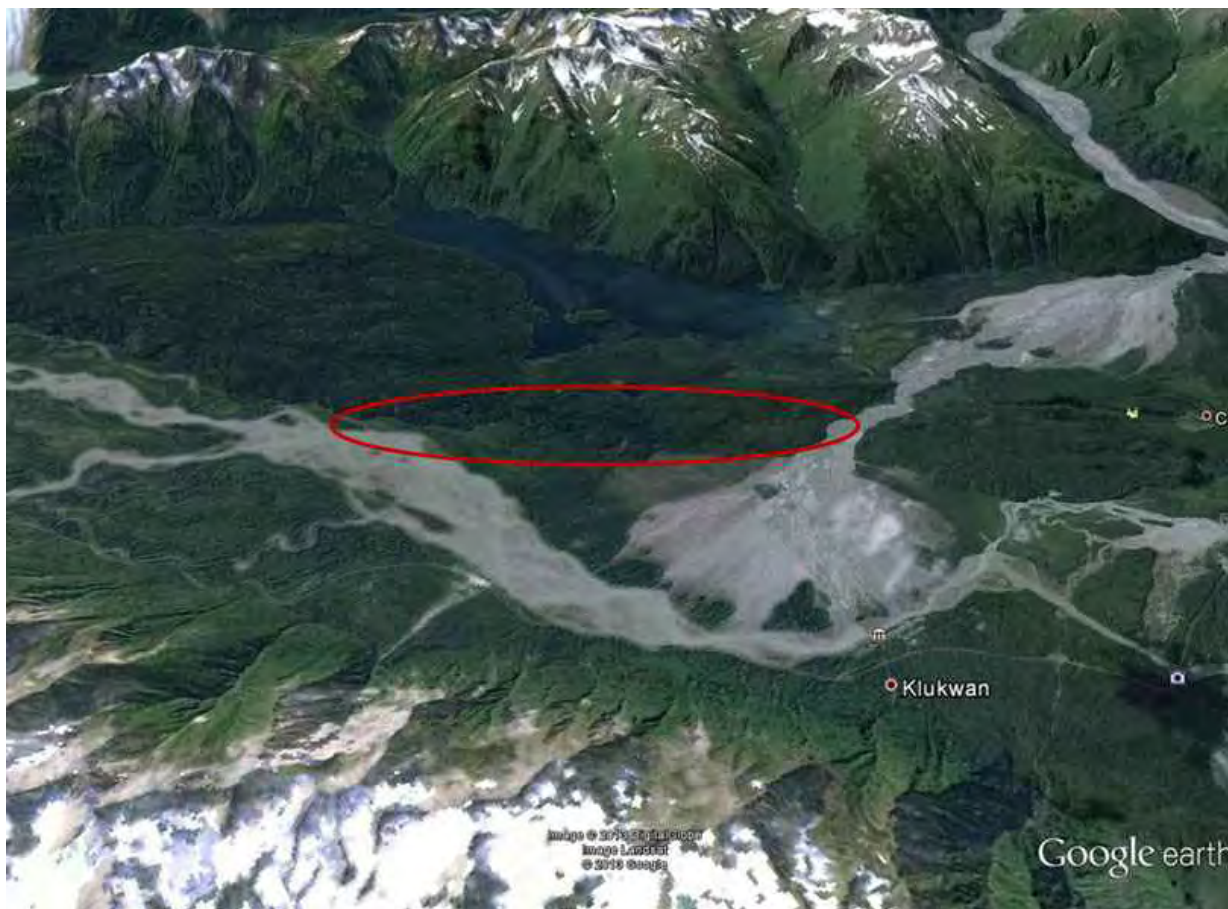
Figure 3. Approximate location of historic Bald Eagle communal roosts southwest of the Council Grounds, 1979–1983 (A. Hansen, Montana State University, pers. comm.; Hansen et al. 1984).

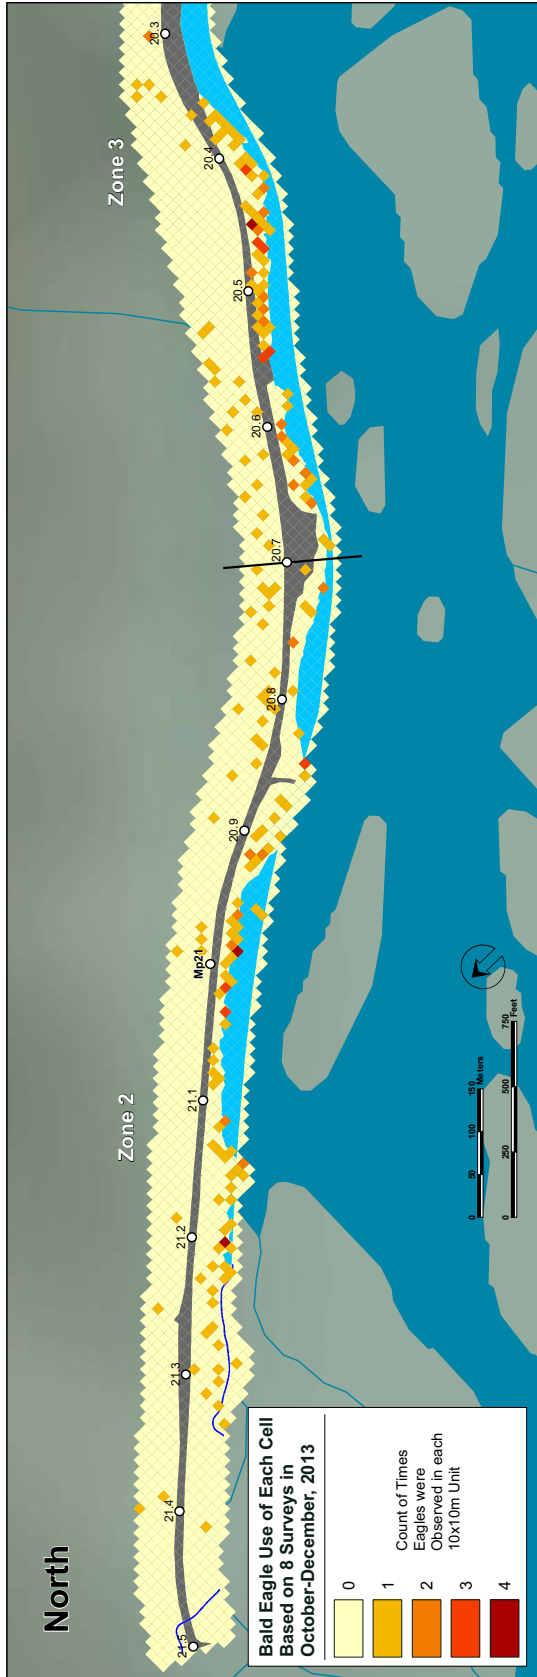
Appendix 2. Frequency of use of perch locations by Bald Eagles within 10 m × 10 m cells in the Council Grounds, Perch Survey Zones 2–5, Chilkat River, Alaska, 16 October–5 December 2013.

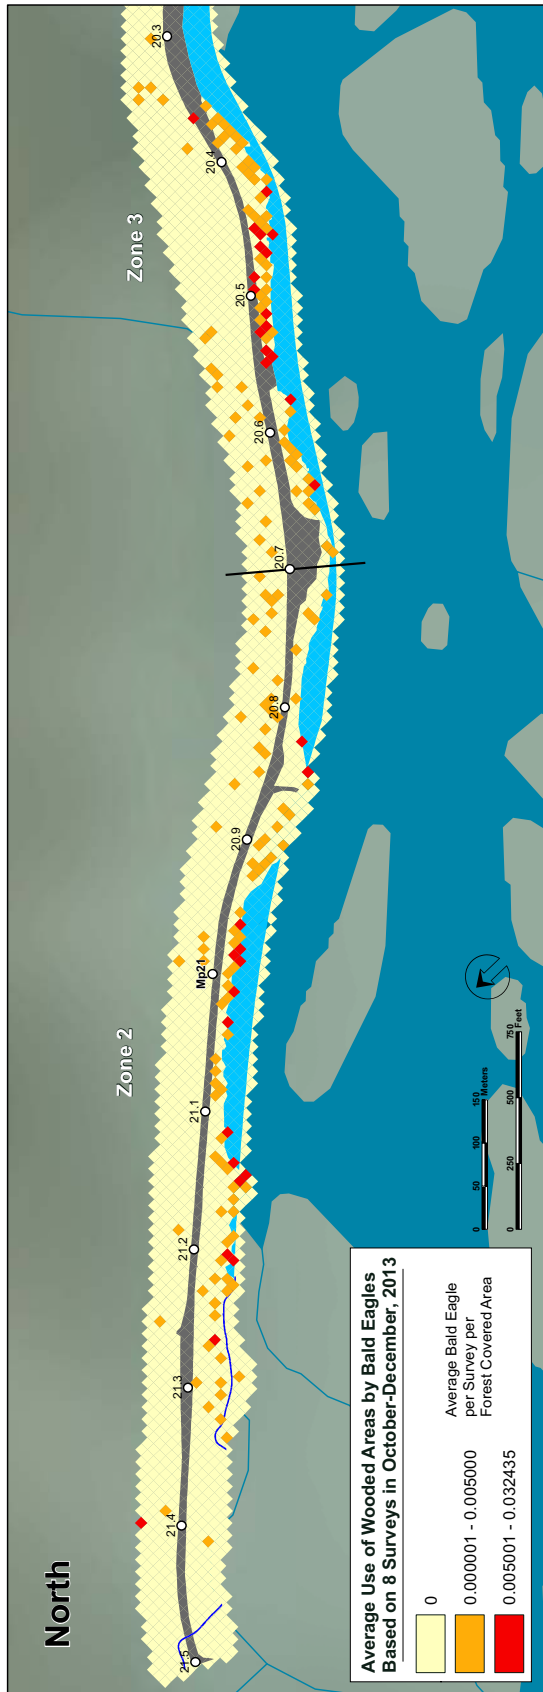
Appendix 3. Average use of perch locations by Bald Eagles within 10 m x 10 m cells in the Council Grounds, Perch Survey Zones 2-5, Chilkat River, Alaska, 16 October-5 December 2013.

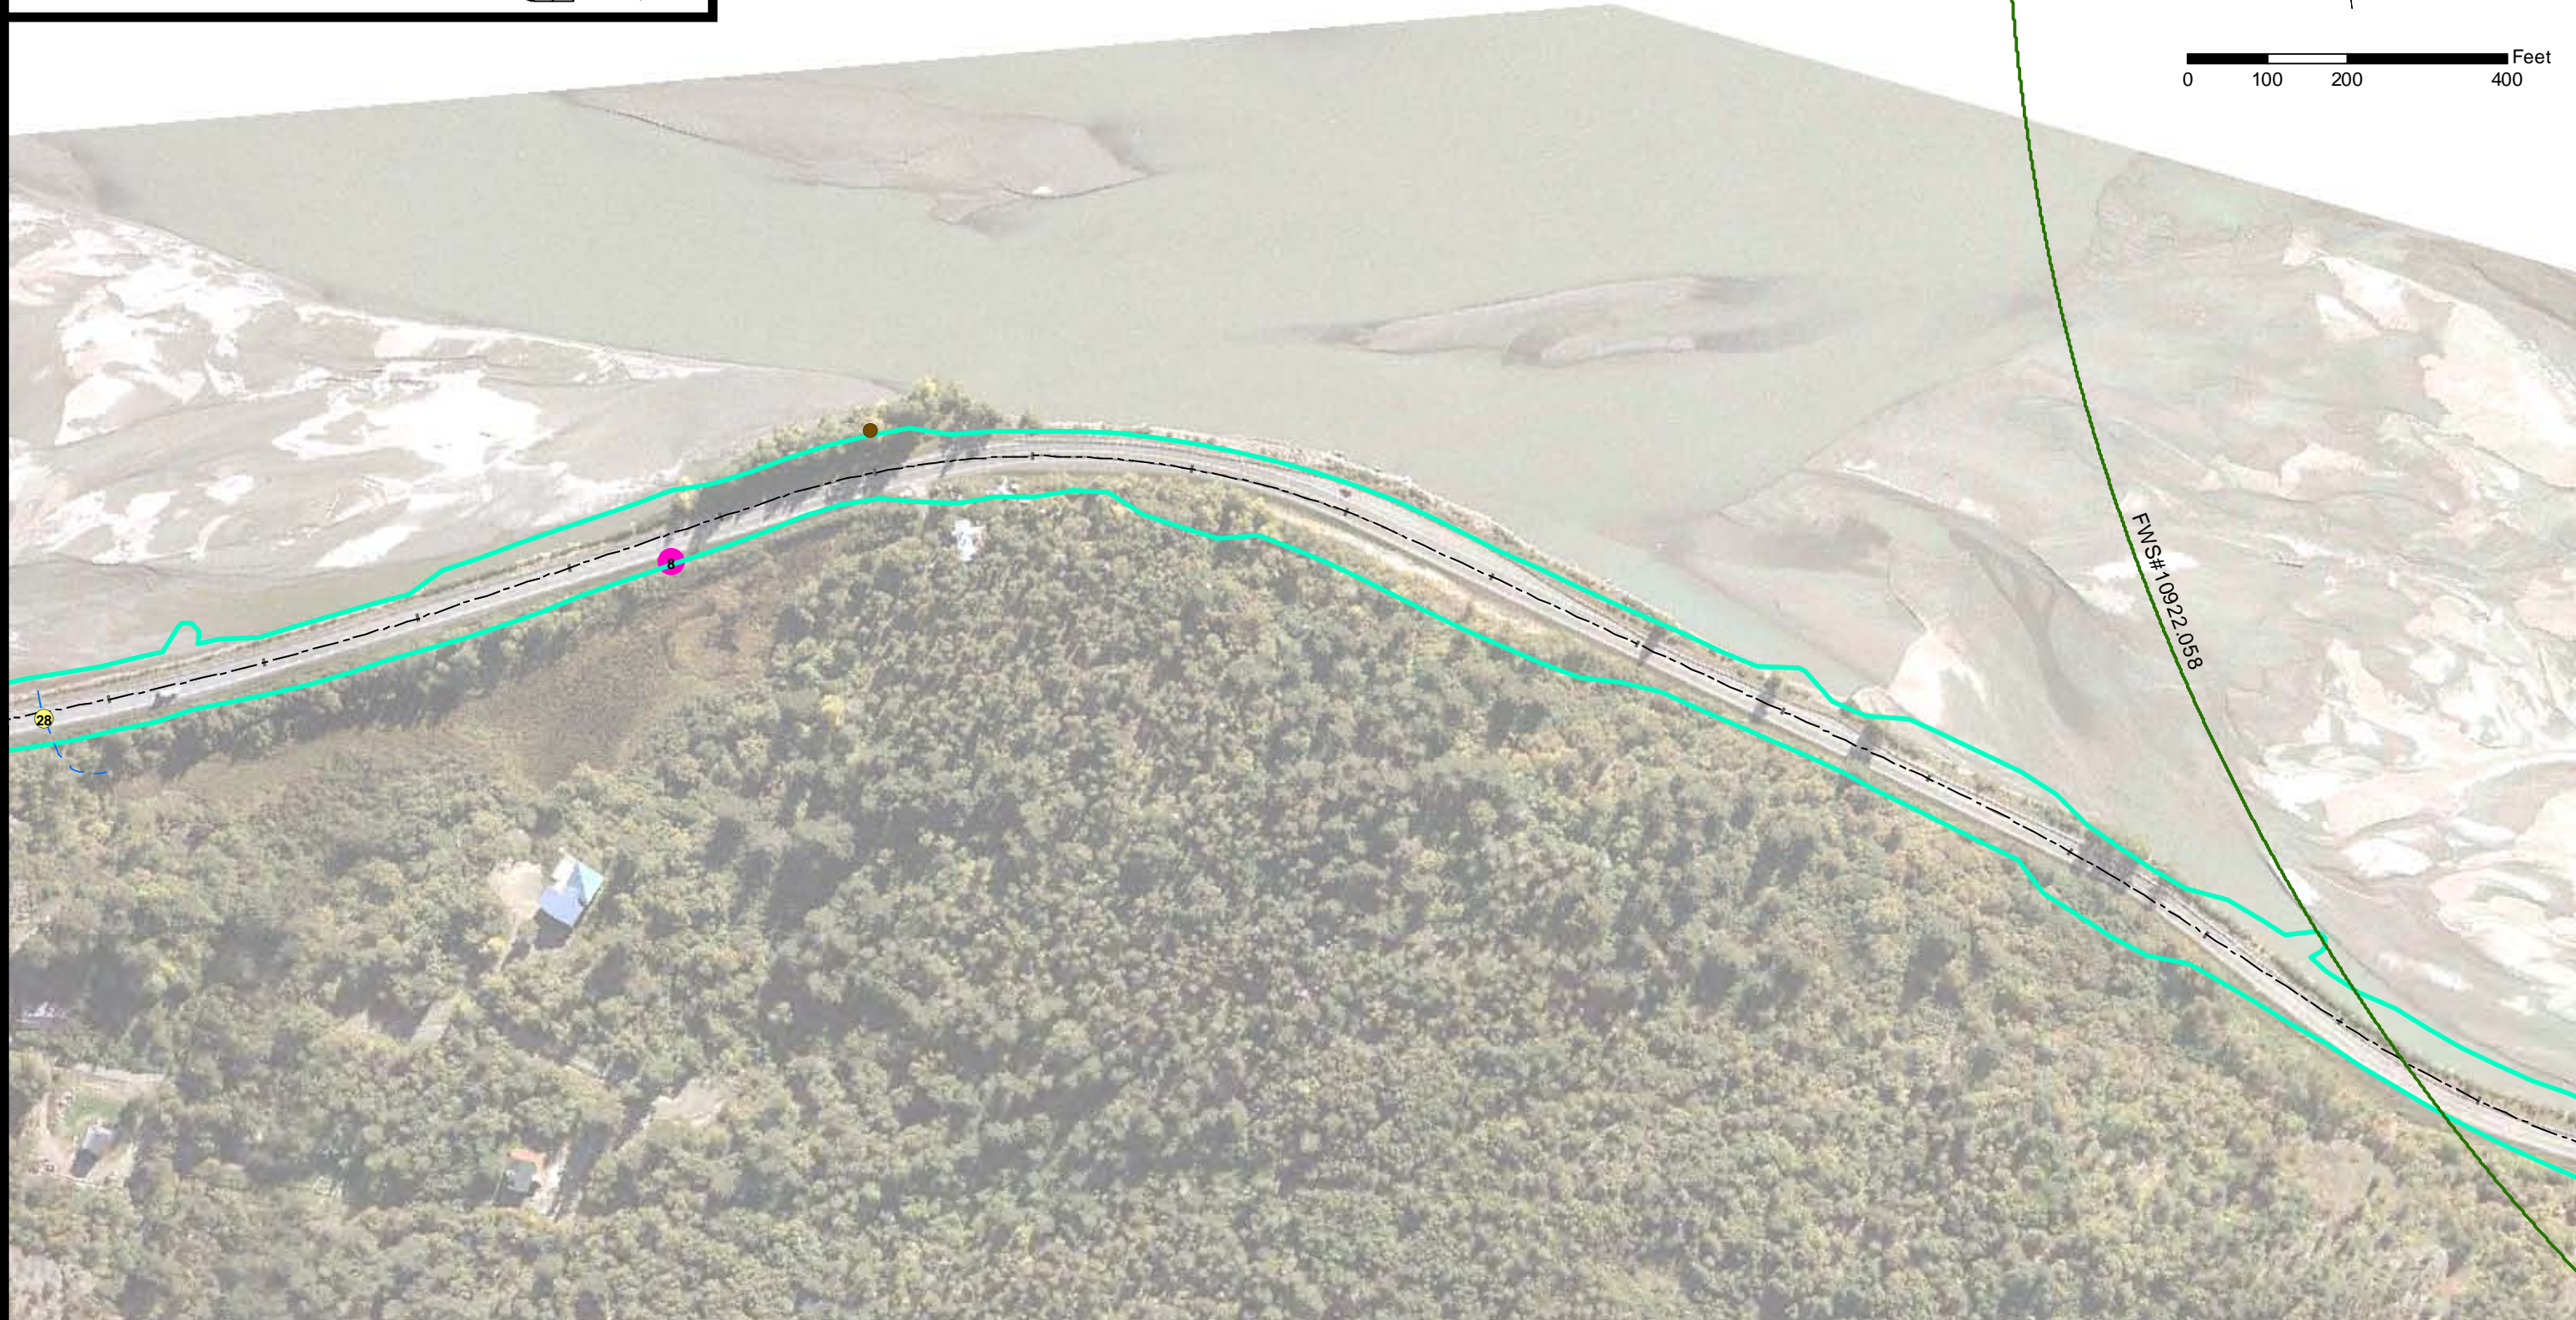
DATE: June 10, 2014 APPENDIX G (06 OF 34)

*Note: Approximate clearing limits shown are based on a distance of 10 feet from toe of slope. Clearing needs will vary throughout the project based on topography and site conditions. Prior to construction, clearing limits would be flagged and opportunities to adjust those limits based on the presence of trees would be evaluated.

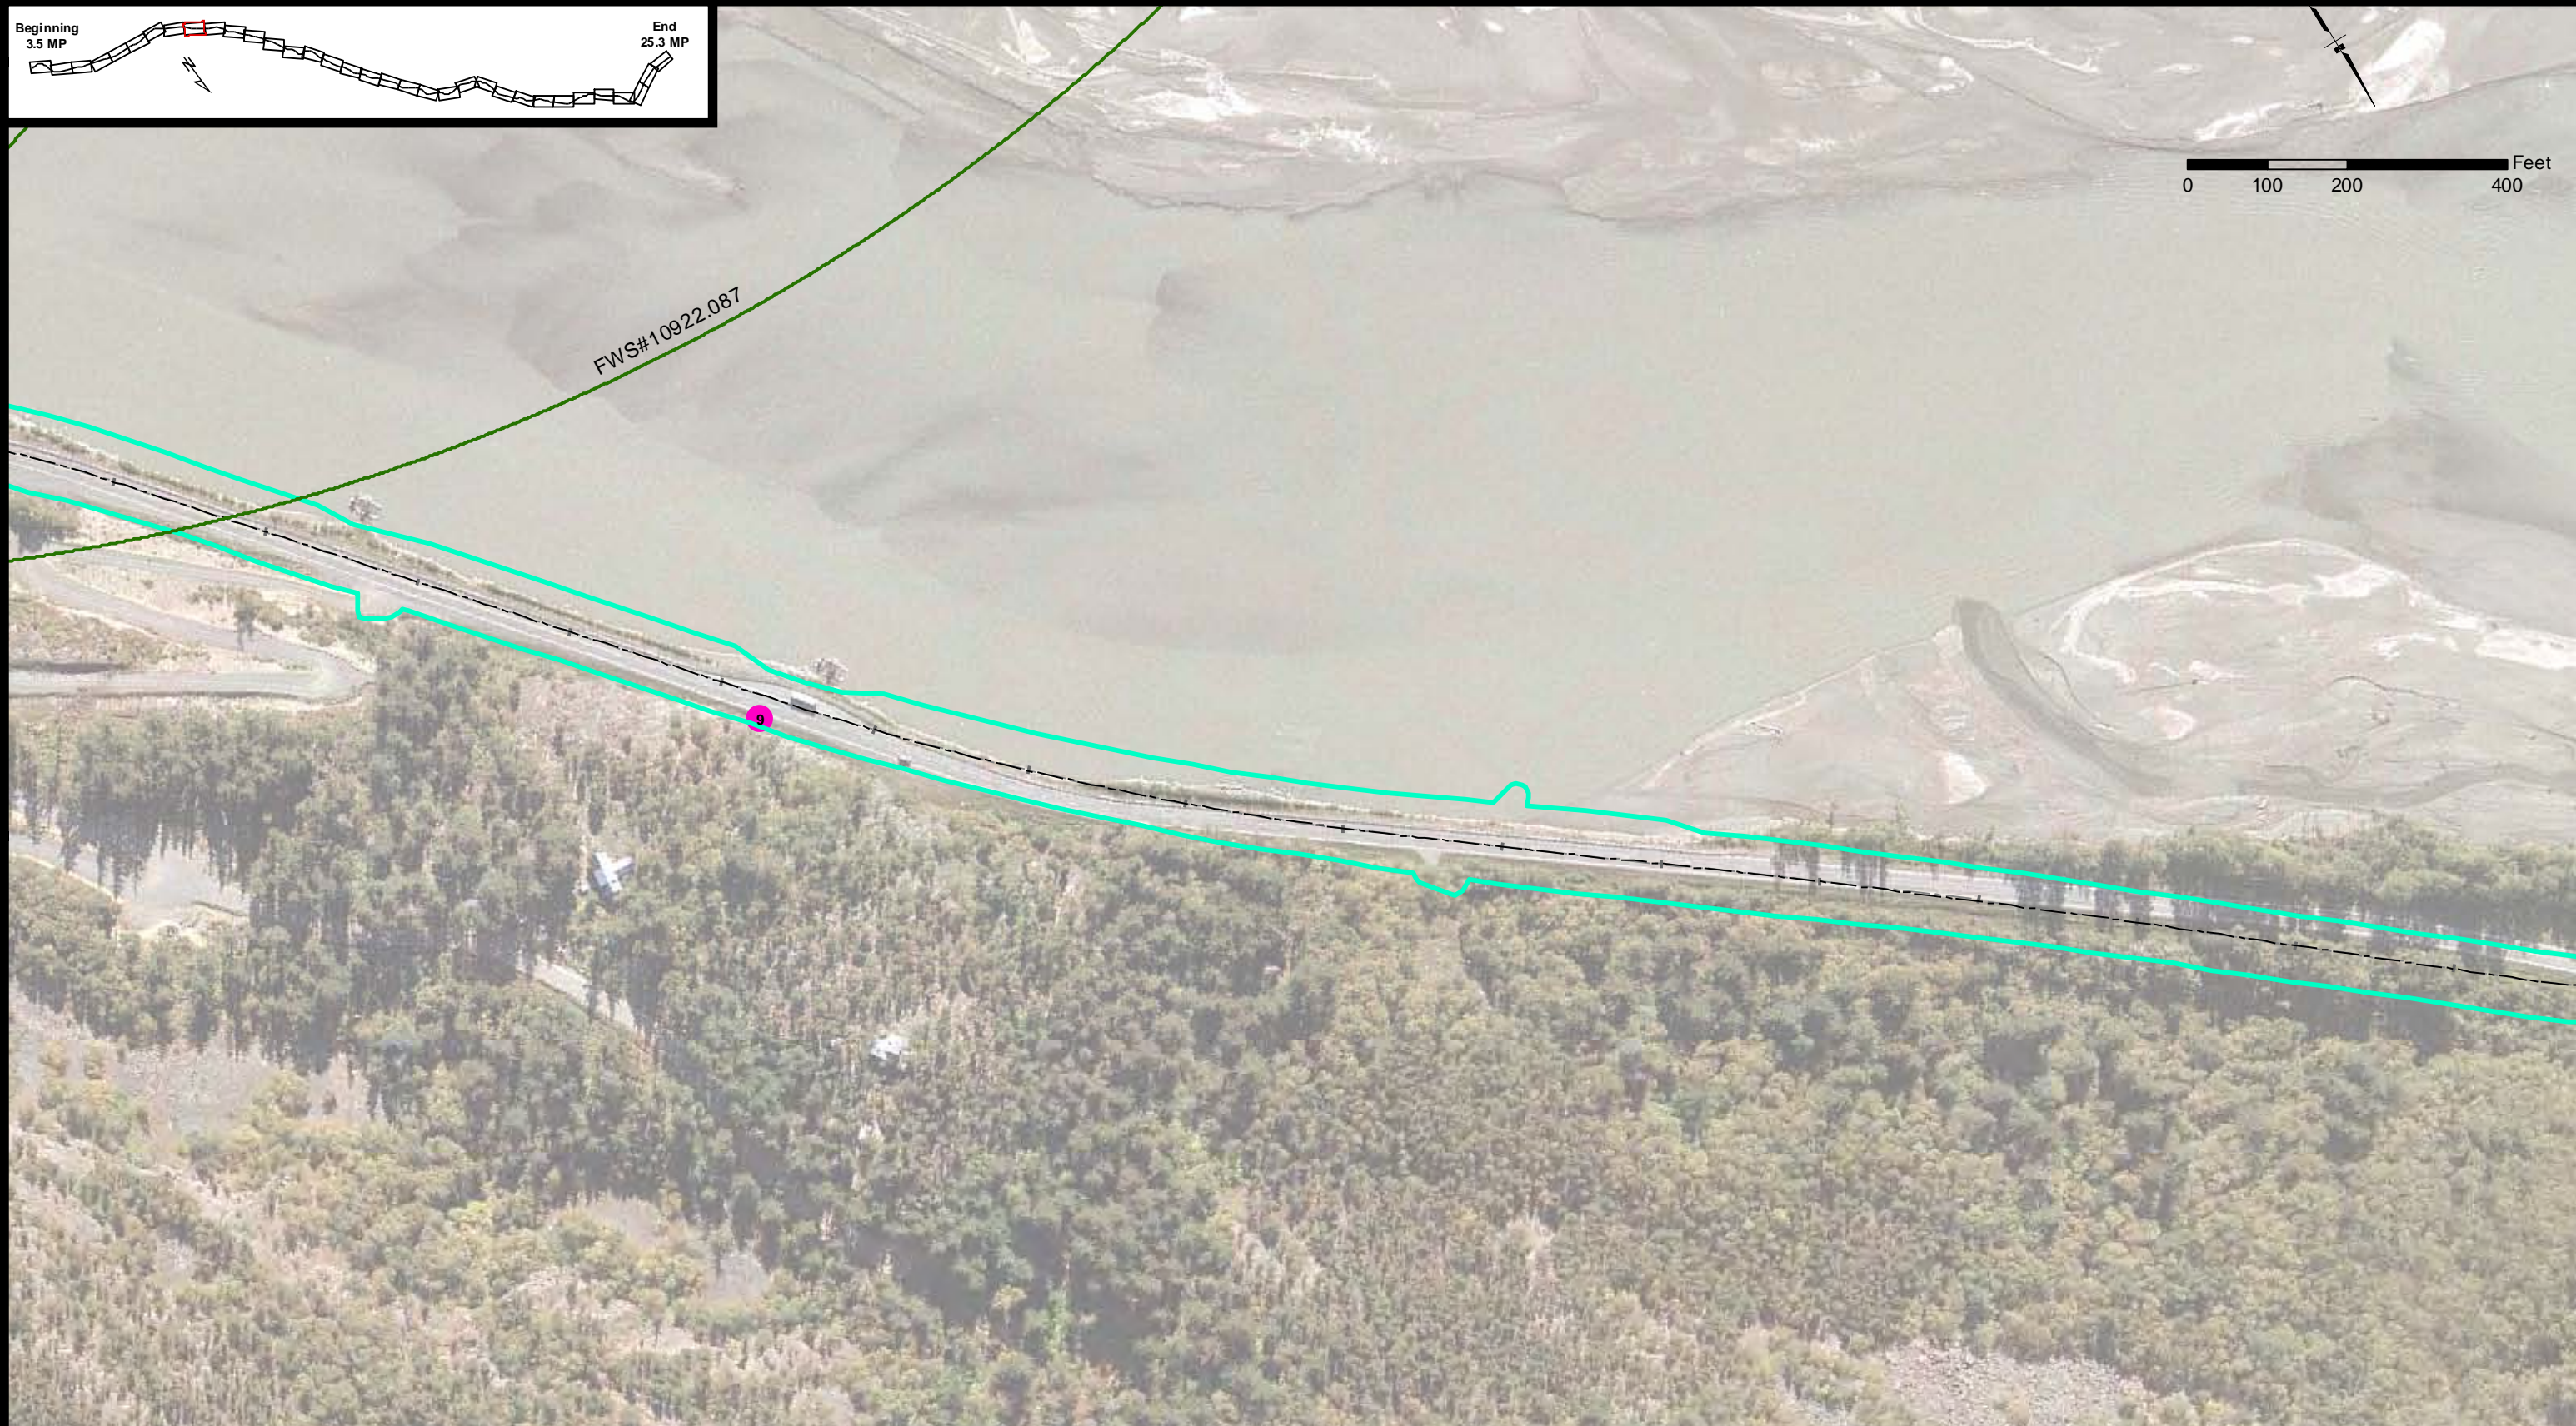
DATE: June 10, 2014 APPENDIX G (08 OF 34)

*Note: Approximate clearing limits shown are based on a distance of 10 feet from toe of slope. Clearing needs will vary throughout the project based on topography and site conditions. Prior to construction, clearing limits would be flagged and opportunities to adjust those limits based on the presence of trees would be evaluated.

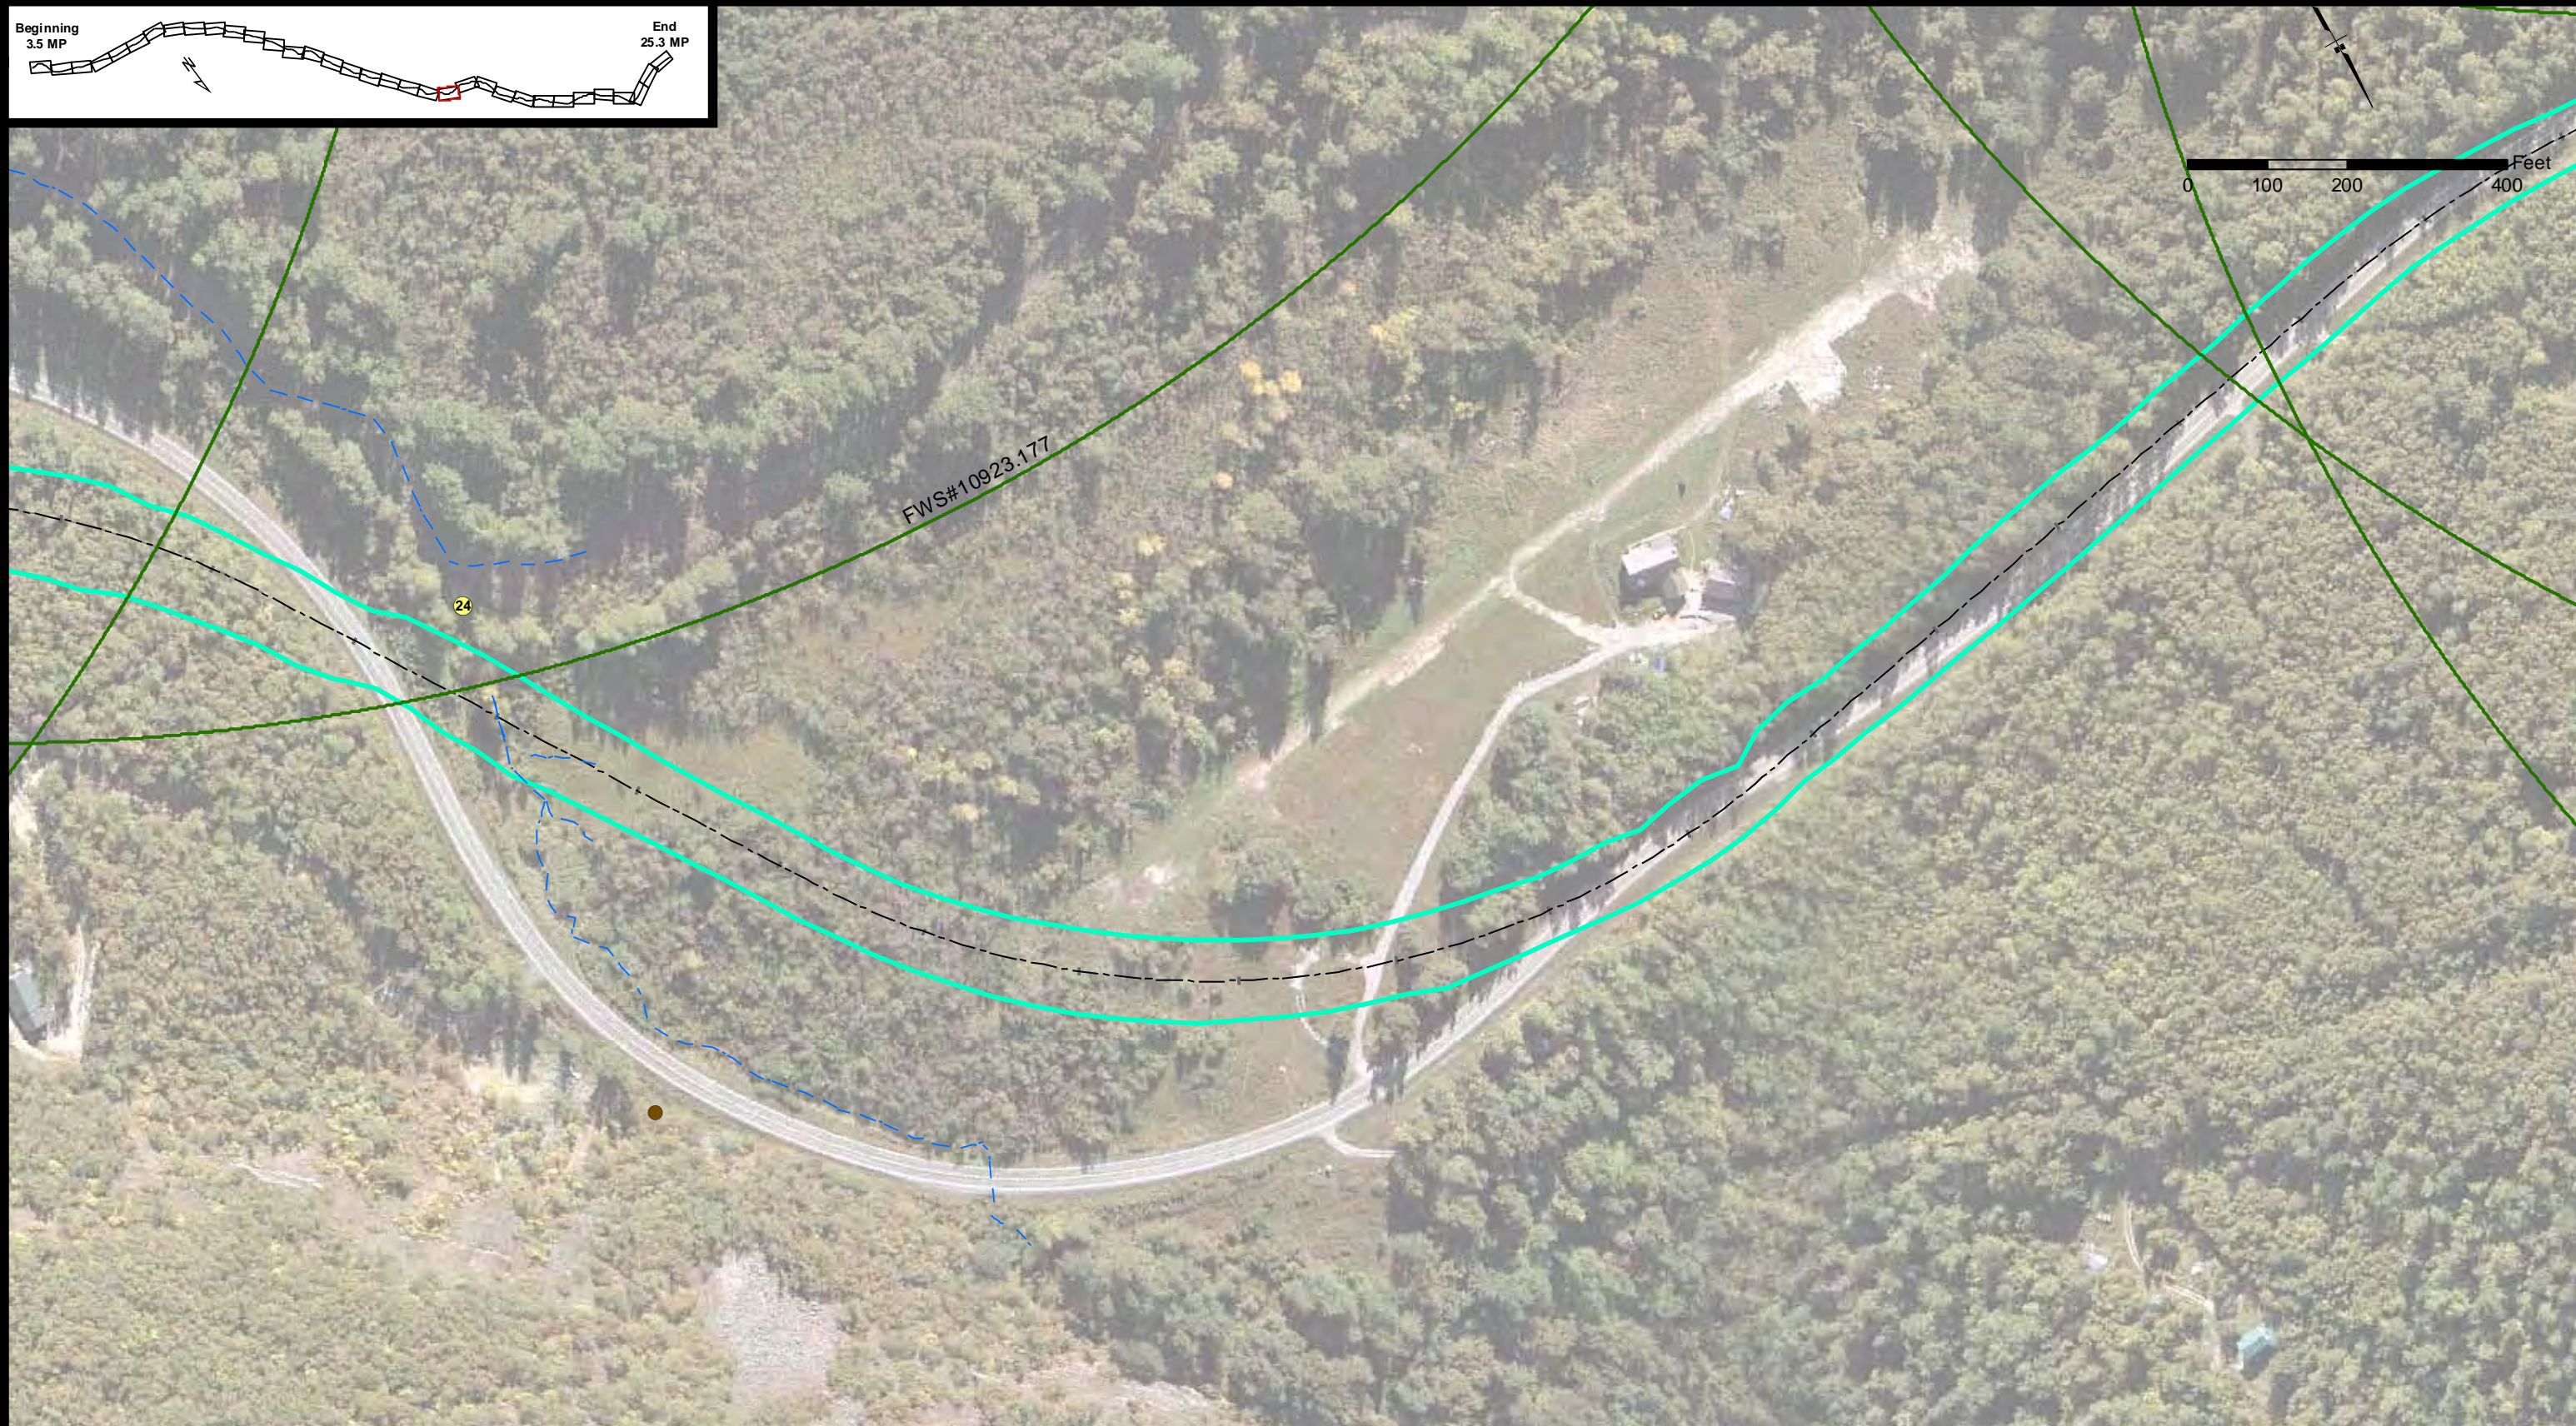
DATE: June 10, 2014 APPENDIX G (21 OF 34)

*Note: Approximate clearing limits shown are based on a distance of 10 feet from toe of slope. Clearing needs will vary throughout the project based on topography and site conditions. Prior to construction, clearing limits would be flagged and opportunities to adjust those limits based on the presence of trees would be evaluated.

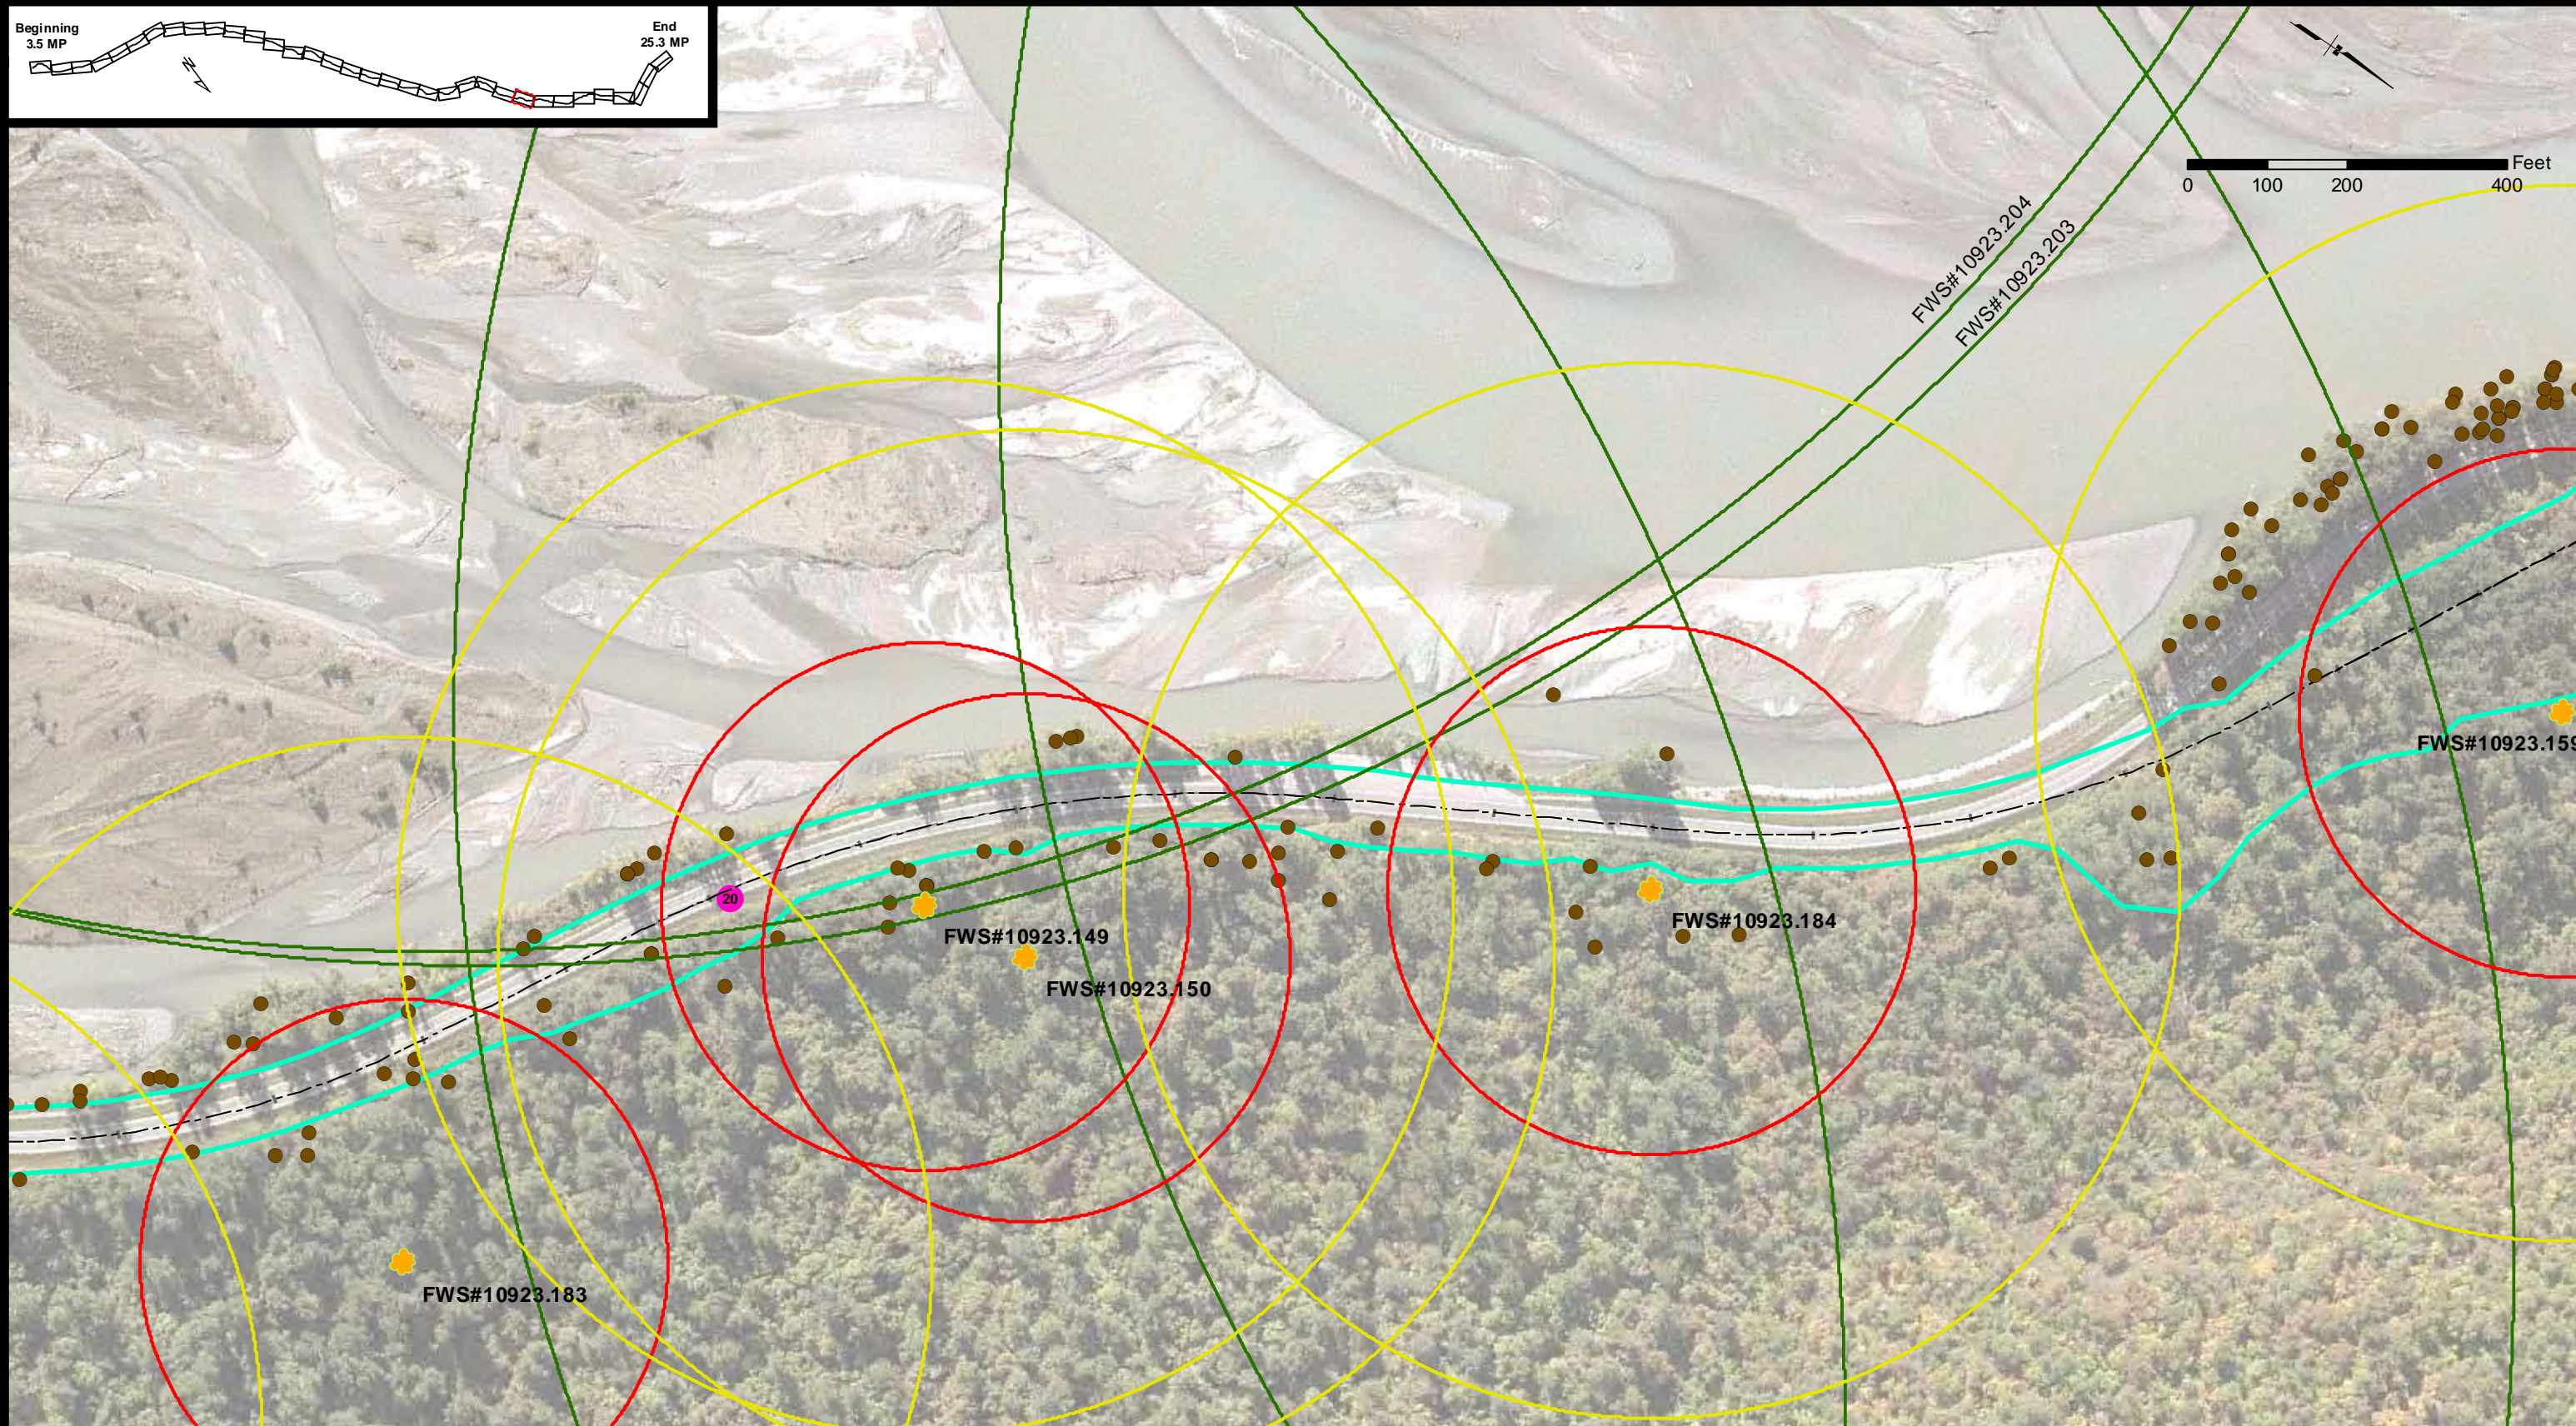
DATE: June 10, 2014 APPENDIX G (25 OF 34)

*Note: Approximate clearing limits shown are based on a distance of 10 feet from toe of slope. Clearing needs will vary throughout the project based on topography and site conditions. Prior to construction, clearing limits would be flagged and opportunities to adjust those limits based on the presence of trees would be evaluated.

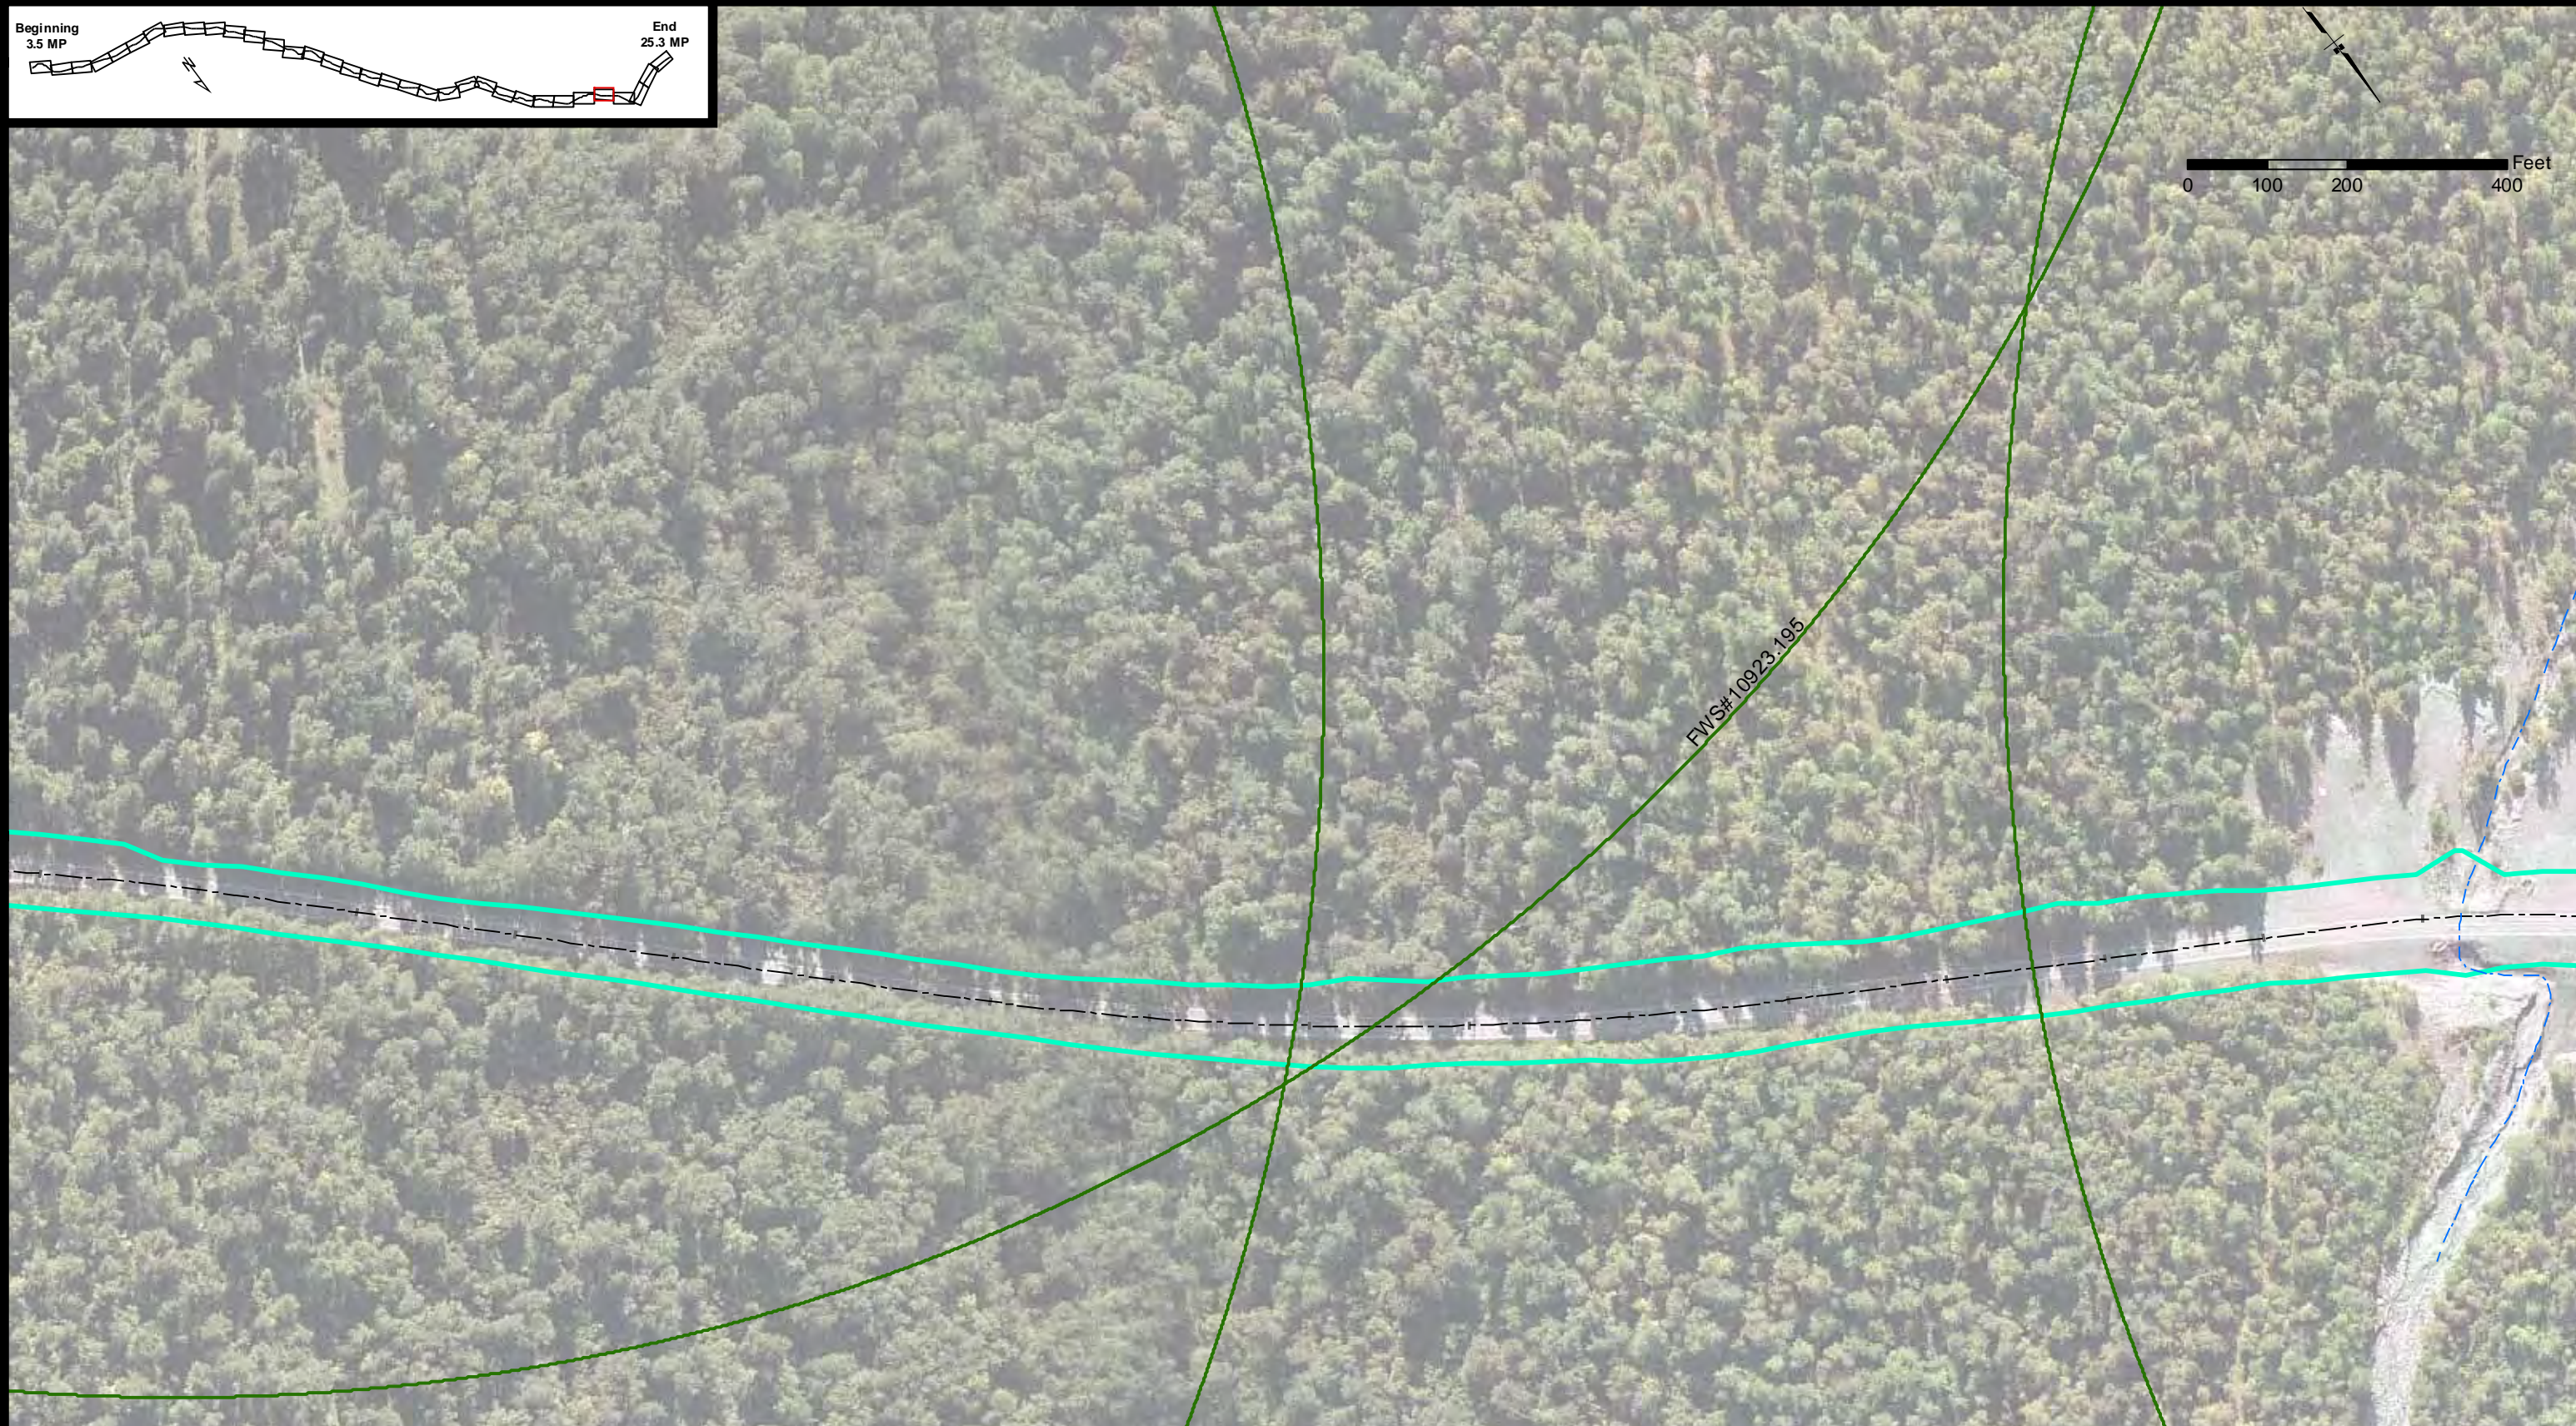
DATE: June 10, 2014 APPENDIX G (29 OF 34)

*Note: Approximate clearing limits shown are based on a distance of 10 feet from toe of slope. Clearing needs will vary throughout the project based on topography and site conditions. Prior to construction, clearing limits would be flagged and opportunities to adjust those limits based on the presence of trees would be evaluated.
