APPENDIX G

Bald Eagle Consultation and Conservation Measures

**AN ASSESSMENT OF PERCH USE
AND POSSIBLE IMPACTS OF
PROPOSED HAINES HIGHWAY
REALIGNMENTS ON BALD EAGLES
DURING FALL AND WINTER,
CHILKAT RIVER, ALASKA**

STATE OF ALASKA
 DEPARTMENT OF TRANSPORTATION
 AND PUBLIC FACILITIES
 DOT & PF Project No. 68606
 HAINES HIGHWAY
 MILEPOST 3.5 - 25.3
 Haines, Alaska

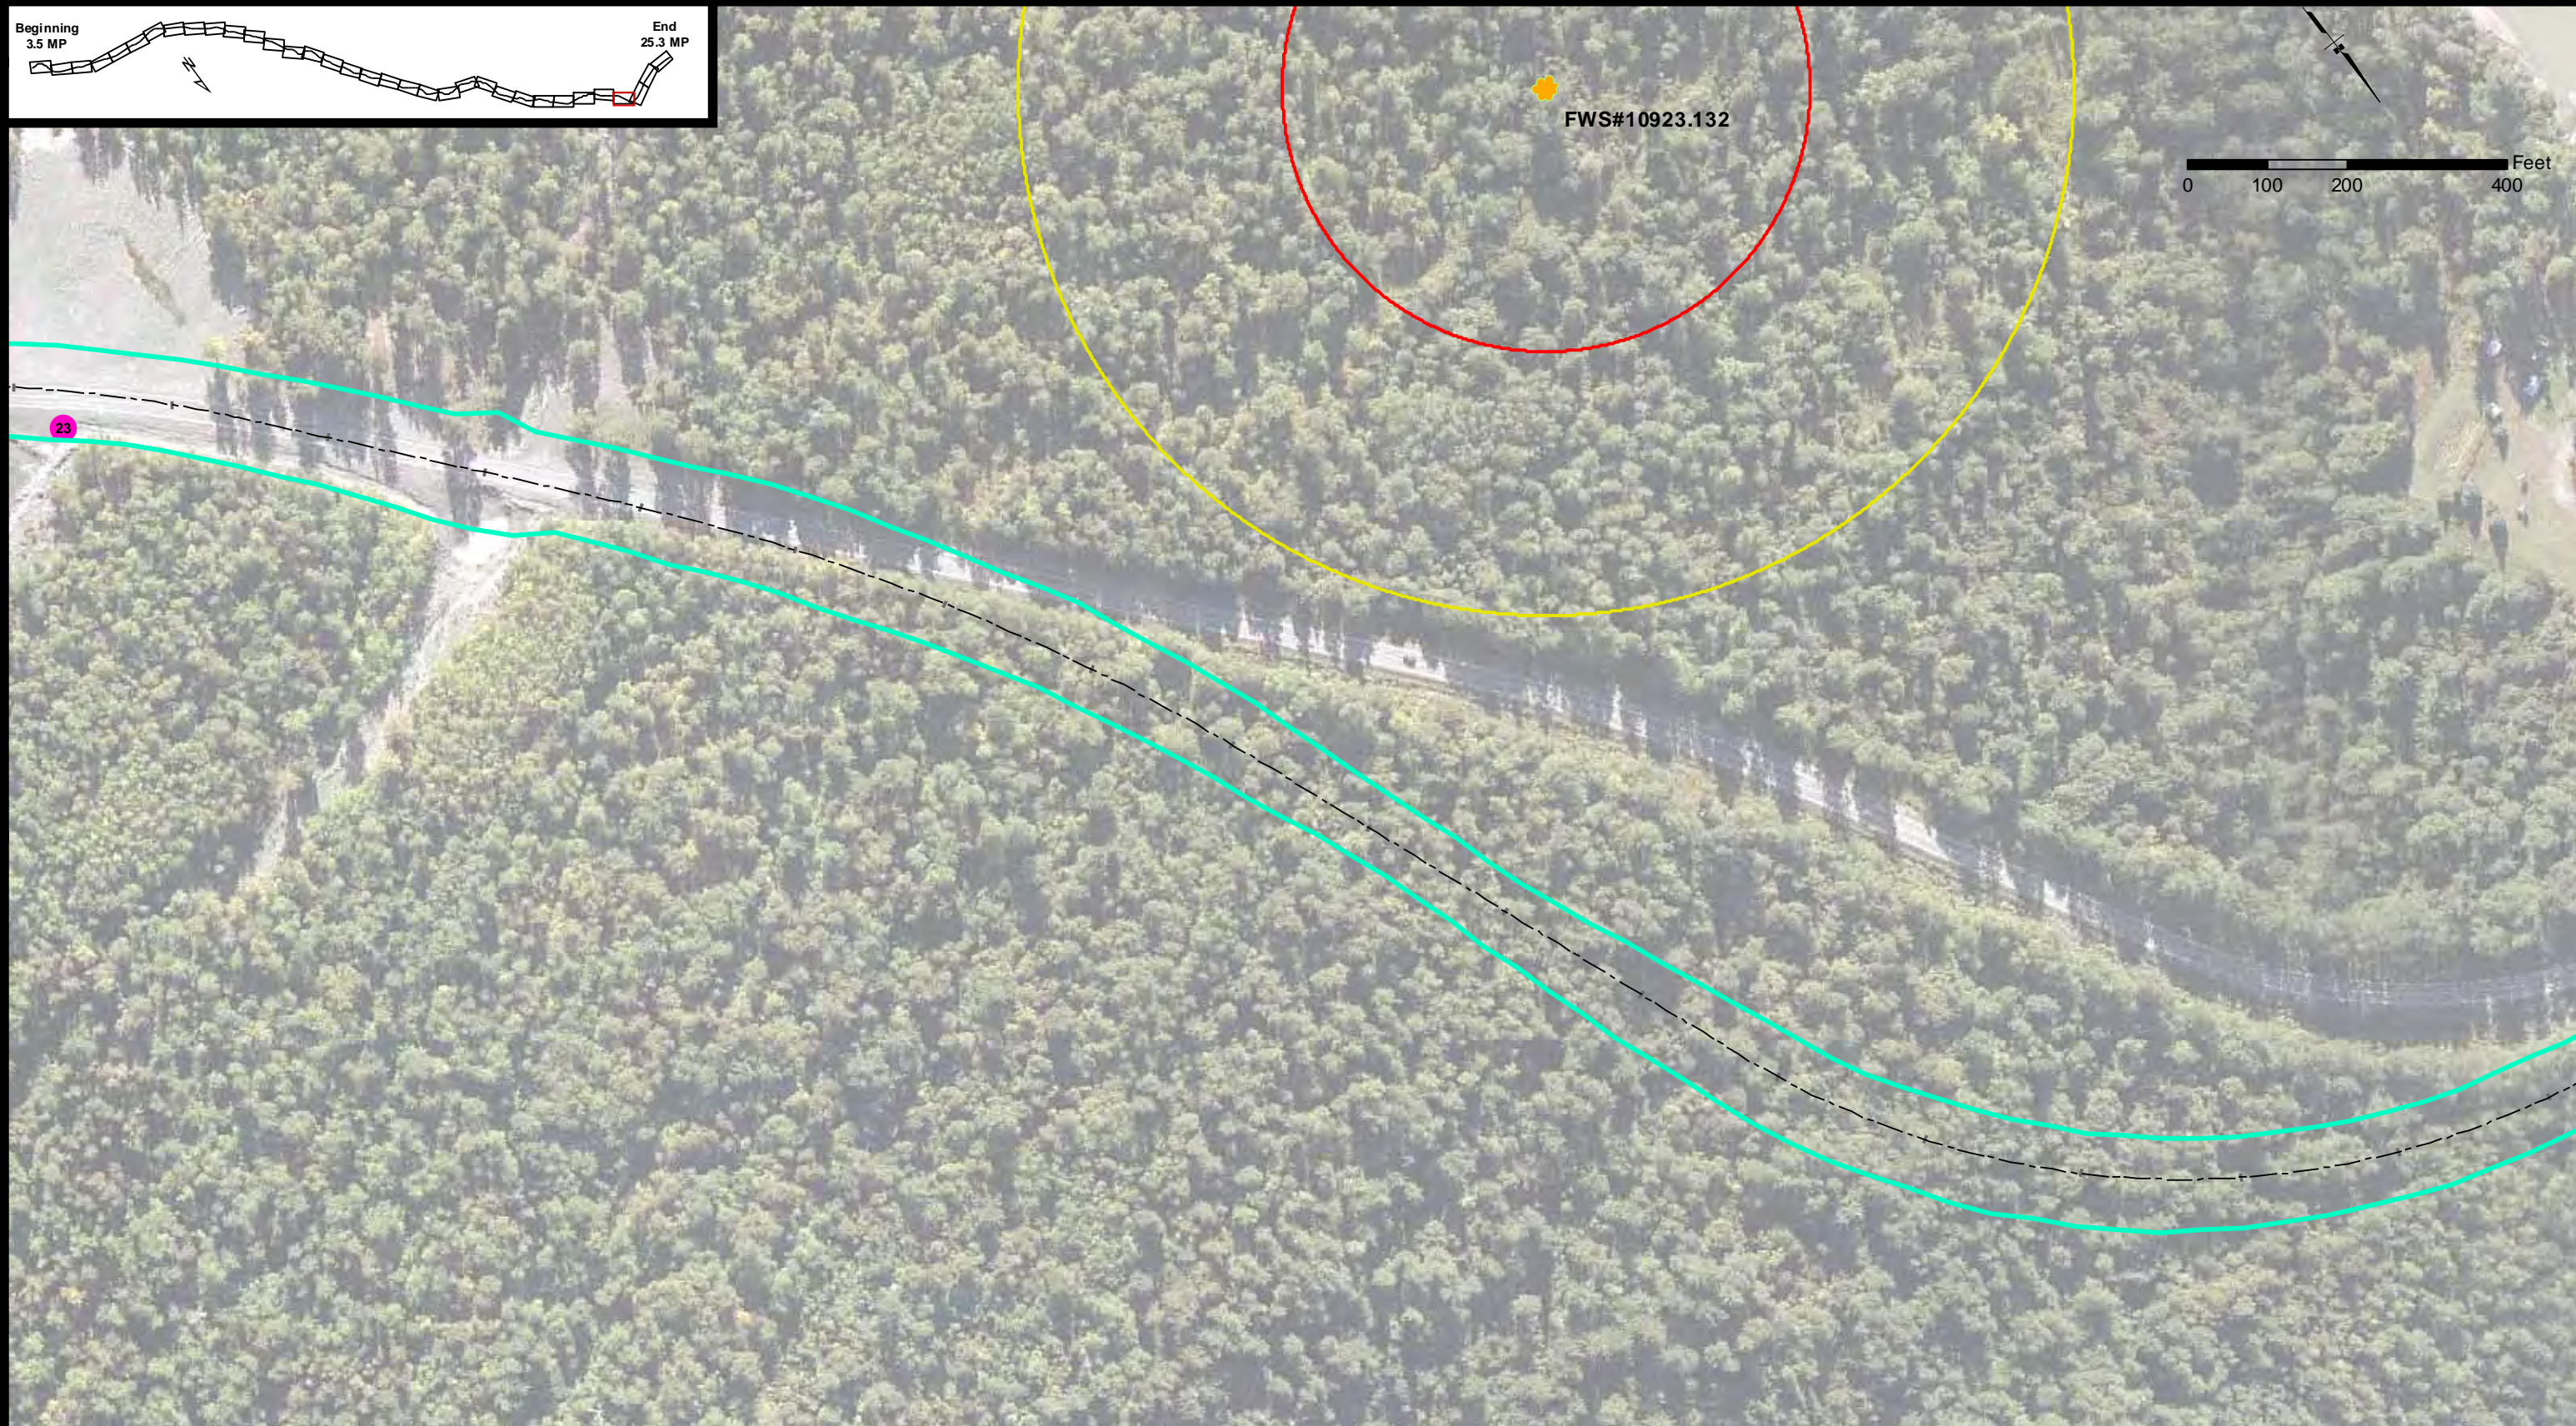
DATE: June 10, 2014 APPENDIX G (30 OF 34)

*Note: Approximate clearing limits shown are based on a distance of 10 feet from toe of slope. Clearing needs will vary throughout the project based on topography and site conditions. Prior to construction, clearing limits would be flagged and opportunities to adjust those limits based on the presence of trees would be evaluated.

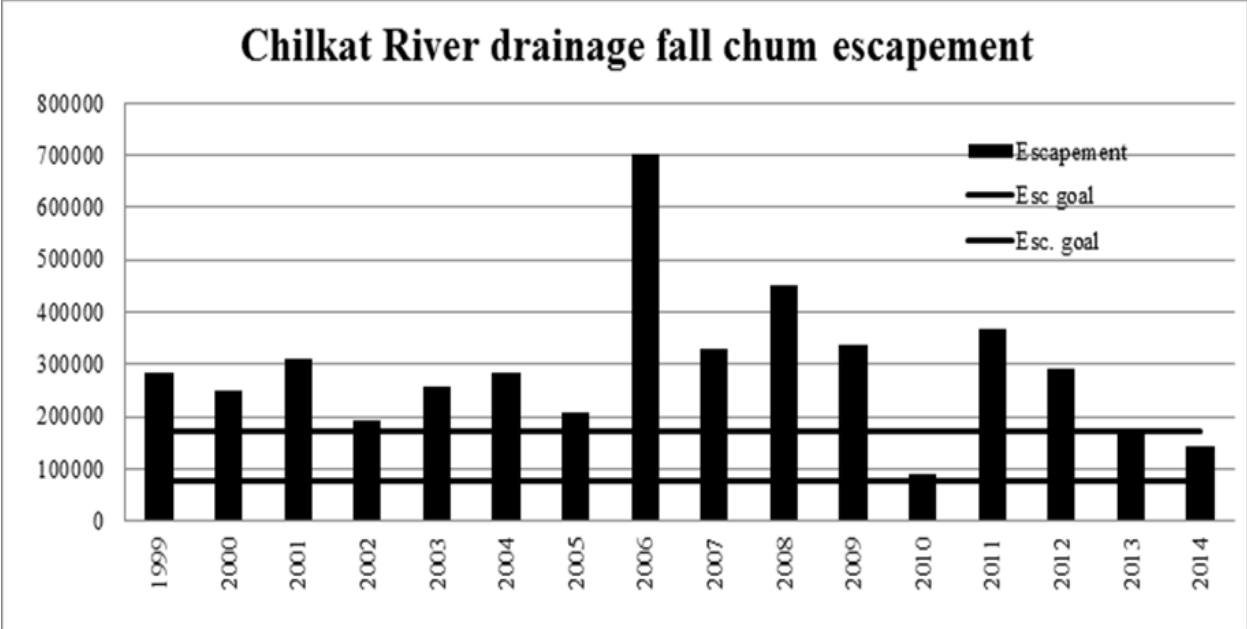
Appendix 3. Chilkat River chum salmon escapement estimates with upper and lower escapement goals, 1999–2014 (figure from R. Bachman, Alaska Department of Fish and Game, Haines, AK).
